1) Progress in the modifications to add cryogenic instrumentation in sect.1-2.

2) Report on the damage/repair of the helium level gauge feed-through on the SSS

V.Parma (AT/MCS)

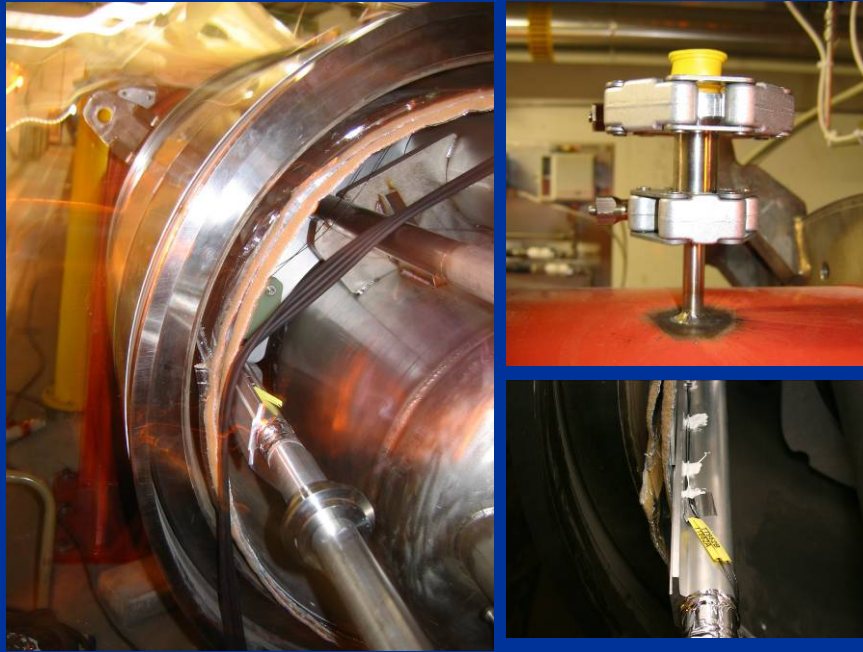
1) Interconnect Q3-DFBX

- 1) Inner Triplet: Interconnect Q3-DFBX
 - Additional port welded on vacuum vessel
 - T gauges glued, wires *thermalised* and routed through Th.shield
- 2) Q4-D2: Interconnect Q4-D2
 - Used existing instrumentation feed-through on Q4
 - T gauges in interconnect, wires routed through Q4
- 3) DSLB: Jumper Q4
 - Additional port welded on vacuum vessel
 - T gauges mounted in jumper interconnect
- 4) DFBAB: Still to be done (DFBAB under vacuum)

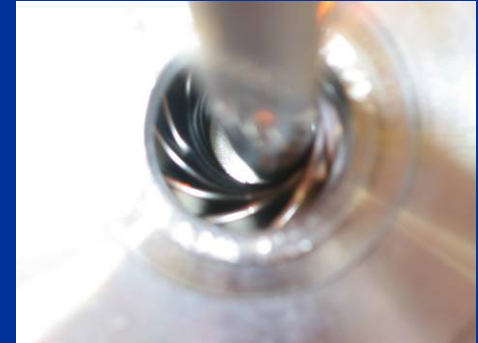
Damaged feed-throughs

- First sporadic discoveries ~ end September
 - Unscrewed (or removed!) clamps
 - Rotated helium guard/pinch-off tube flange
 - **Damaged bellows due to twisting**
- Larger extent of events discovered in 2-3 and 1-2

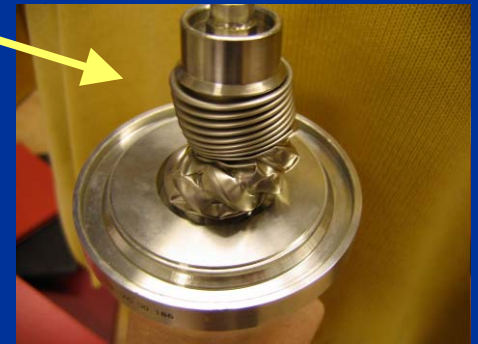
View inside cryostat

- Rotation of flange for improved accessibility (US brazing machines?)
- Interference on closing of interconnects bellows? (1 case confirmed by IEG)
