LHC: Bus-Bar delivered on 30-08-06

Rev. 0 date 18.10.06 - Report about activities for reconditioning of Bus Bar sets delivered wet by water on 30-08-06 (Ref. NC-CERN 409)

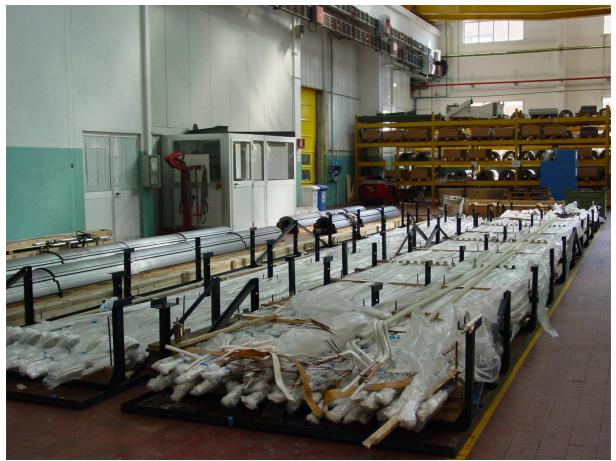
Fig. 1: Bus-bar storage

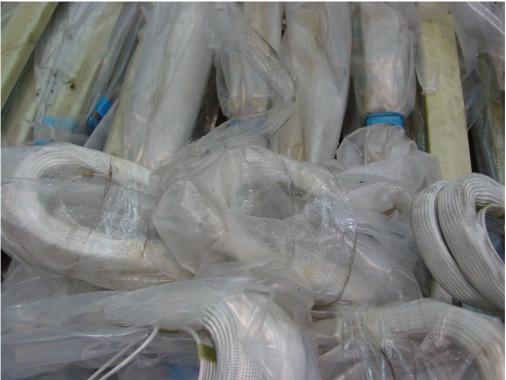
When the first bus-bar set were taken from the rack in order to be assembled into cold mass, a lot of bars showed water inside the nylon bag, as reported in the following Fig. 2, 3 and 4.

Fig. 2: Bus-bar inside nylon bag

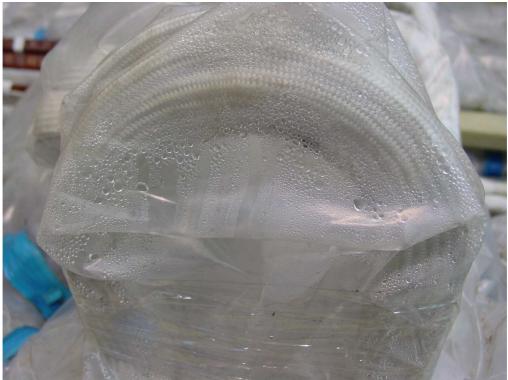
Fig. 3: Bus-bar inside nylon bag (detail)

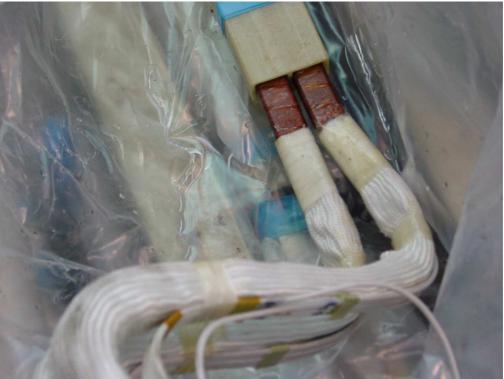
Fig. 4: Water inside the nylon bag opened

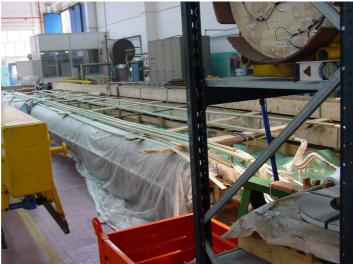
The first test done in order to dry the bus-bar was to put them under the heat of electric light (2 lamp of 500 W) see Fig. 5. This was efficient for the bus-bar end where the glass woven protection was effectively dried but the following electrical test showed that there was a lot of water inside the glass-epoxy case.

Fig. 5: Bus-bar ends under lamps

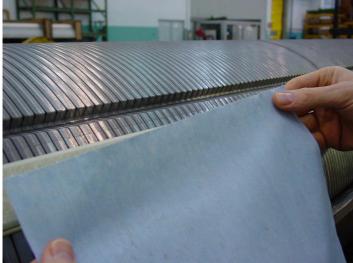
Fig. 6: Clean and dry cloth before bar drying

Then was decided to remove the lids of the glass epoxy case and manually dry the bar inside; the following fig.6, 7, 8, 9 and 10 shows the quantity of water found inside the case.

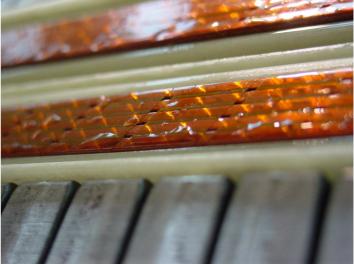
Fig. 7: Detail of the surface to be dried

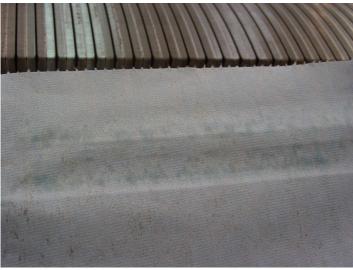
Fig. 8: Wet cloth after bar drying

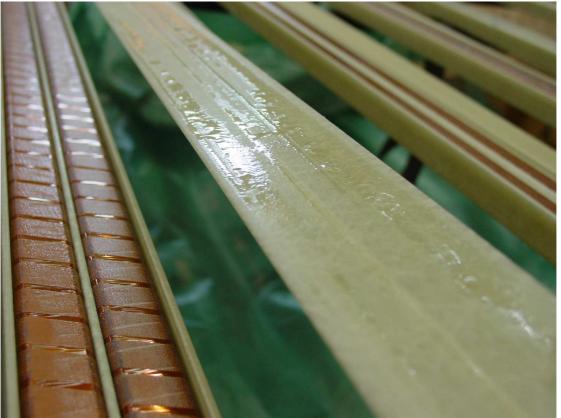
Fig. 9: Water found inside after lid removal

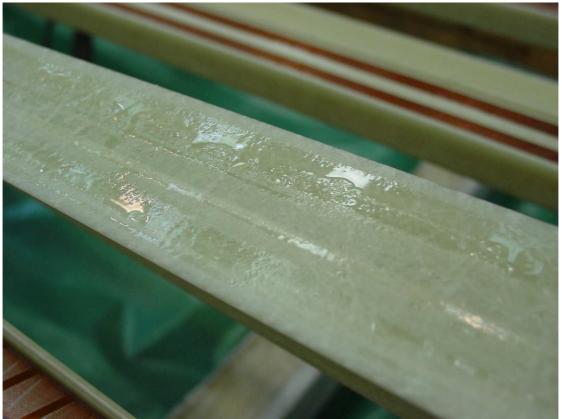
Fig. 10: Water found inside after lid removal

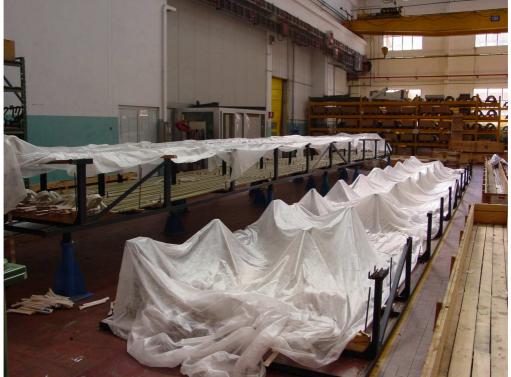
Fig. 11: Bus-bars rack on supports

All the test showed that the only way to dry the bus-bars is to open the glass epoxy case and manually dry the bars and the case. So the rack was put on support (in order to allow a better air circulation) and all the bus bars nylon bags and caps were removed as show in the following Fig. 11 and 12; then in small groups the bars were moved to other station for the opening of the case and the drying (see Fig. 13).

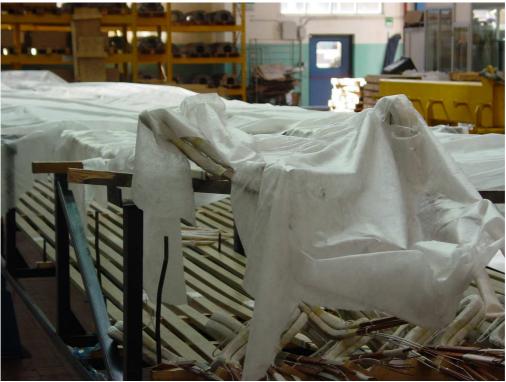
Fig. 12: Bus-bars without nylon bags on the rack

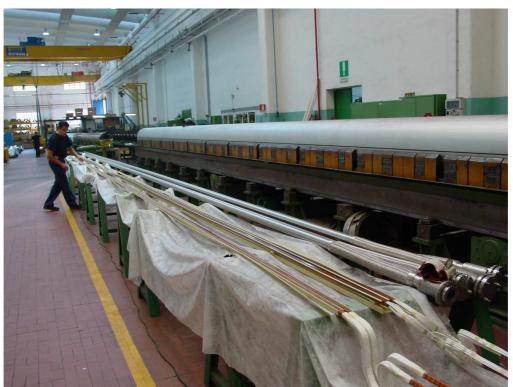
Fig. 13: Bus-bars opening and drying
