Bus Bars problems since beginning of production of cold masses at Ansaldo Superconduttori

List of non conformities opened by Ansaldo Superconduttori:

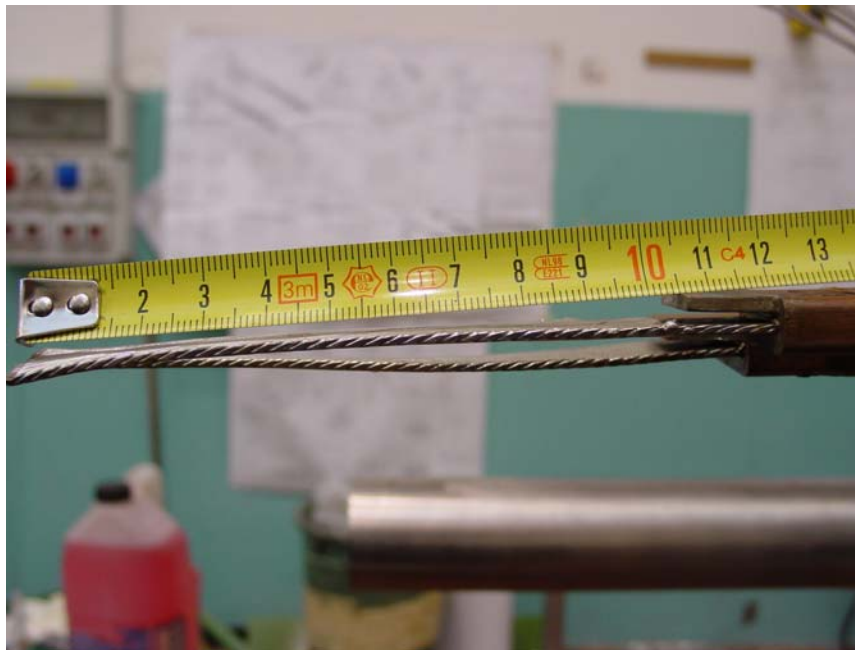
NCR98

Description: During the assembling of cold mass nr. 2010, a dimensional check of bus-bars showed a reduced length $L=105$ mm (nom. $L=120$ mm) of the sc cable of bus-bar installed on M1 line - lyre side.

Bus bar Id.: **00000024** (type B)

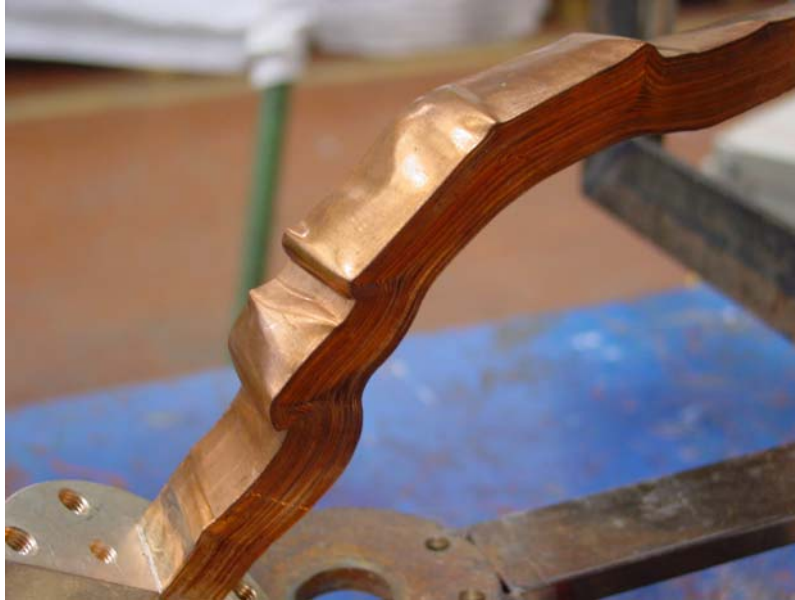
NCR161

Description: During electrical connection of bus-bars, after longitudinal welding of CM 2066, we found a deformation of the bus-bars nr.A186 for diode connection (bus-bars set nr. HCDCBHA055-BI000186). Besides this bus-bar is in contact with bus-bar nr.A186/C.

Bus bar Id.: **HCDCBHA055-BI000186 (A)**

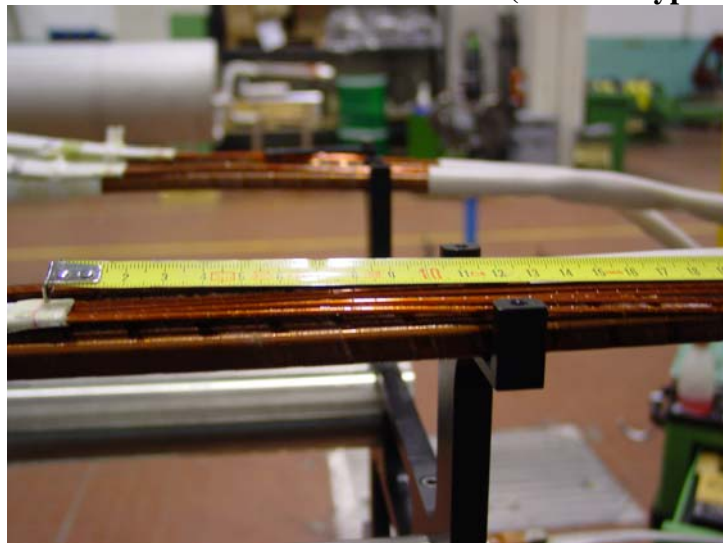
NCR177

Description: With reference to dwg. nr. LHCCCHA0001-0002-0003-0004 (all rev, index D), the length of the glass cloth of auxiliary bus bars is too short (about 120mm) on both sides.

The end taping is in the position where the clamps (DWG,nr. LHCMB_E0057 & 0058) have to be mounted.

The glass epoxy plate 12x15x2.2mm (dwg. nr. LHCCCHA0003 pos.6) is missing.

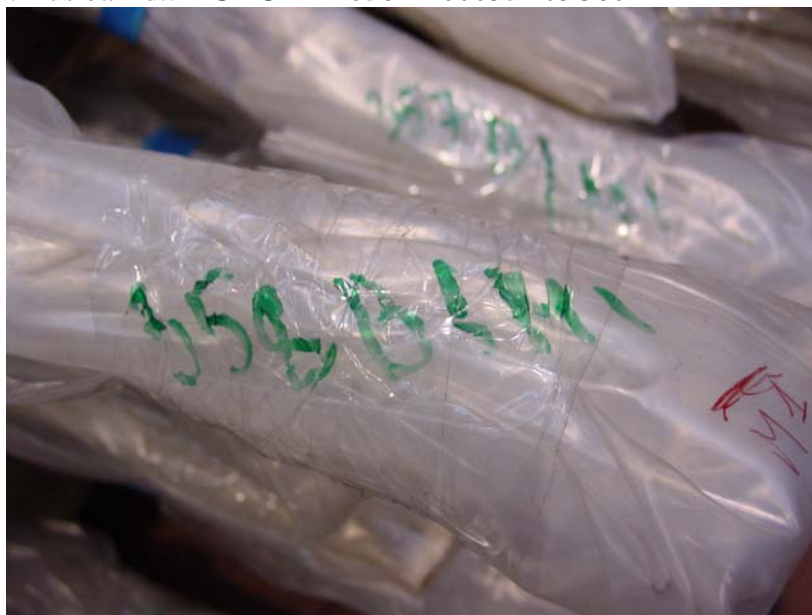
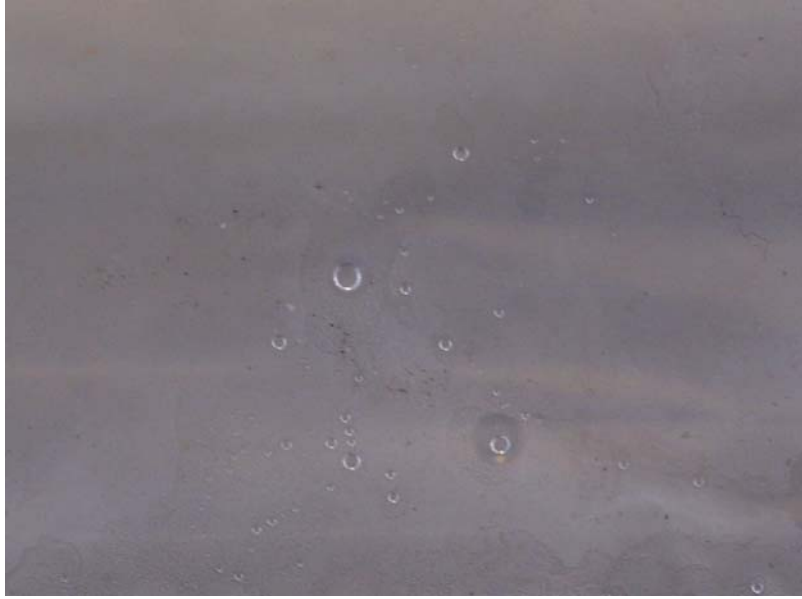
NCR268 (See also NCR 267)

Description: During electrical check of bus-bar nr. B-360 (id. nr. HCDCBHA056-BI000360) just before longitudinal welding of CM 2137, a low insulation resistance has been found. Cause of this problem seems to be high humidity / water, get during transport of bus-bars. Same problem we found on bus bars regarding set nr. from A-336 to A-345 and from B-351 to B-360 (ref. to NC CERN 268)

Cold mass affected: During incoming inspection of bus-bars from nr. A-336 to A-345 and from nr. B-351 to B-360, we found water inside the bus bur assembly.

Cause of this problem seems to be related to a bad storage or packaging during transport.

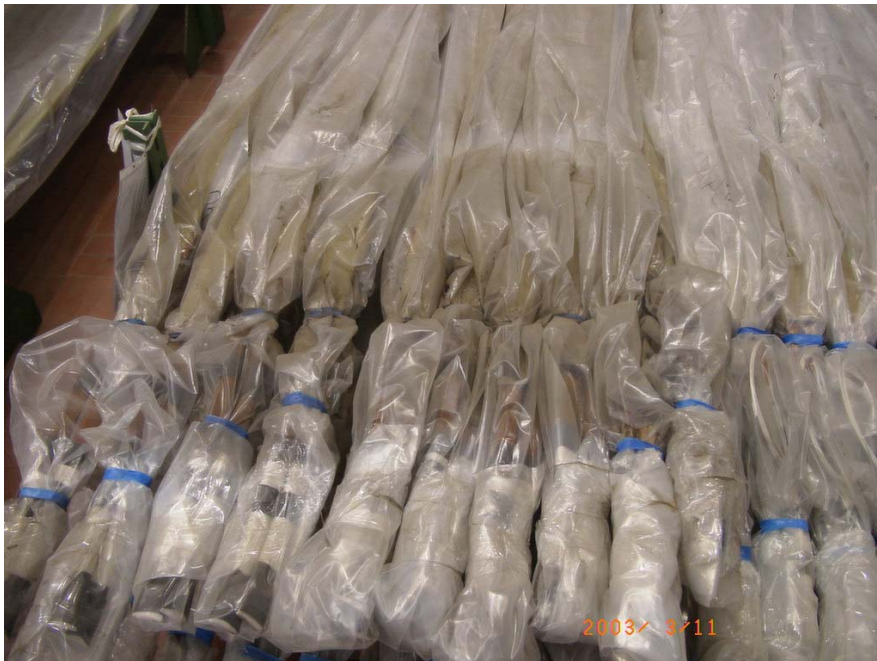
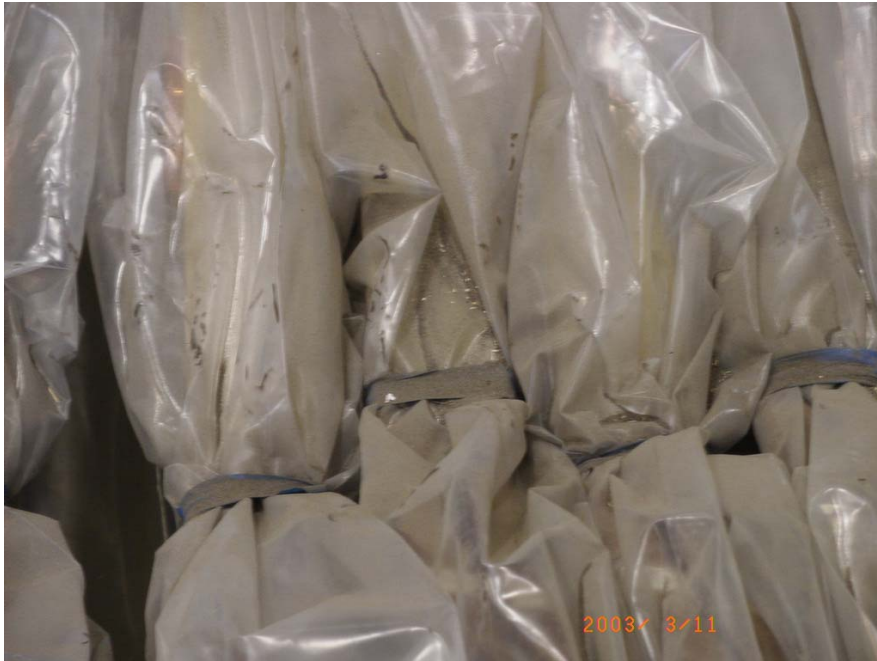
Cleanness

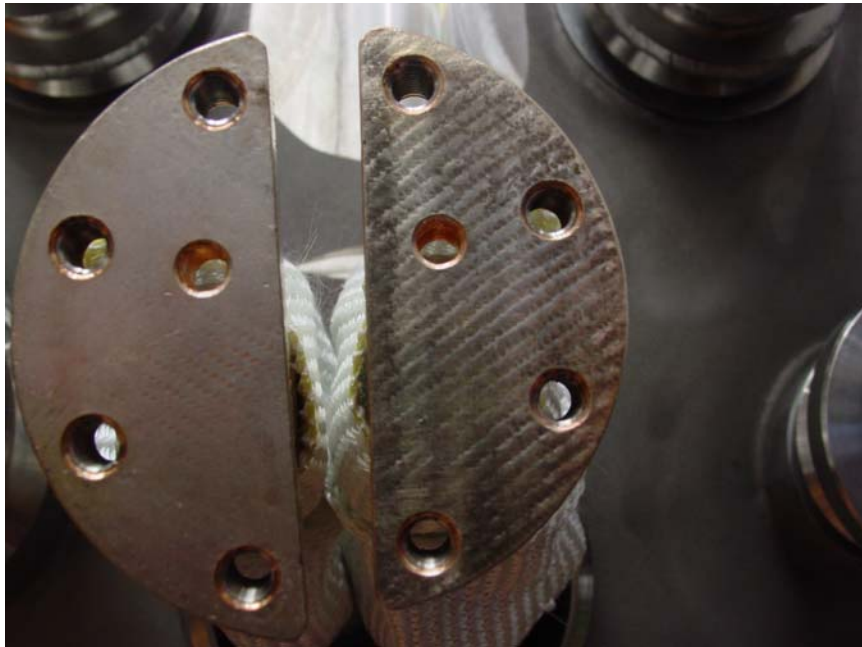
Rugosity at diode connections

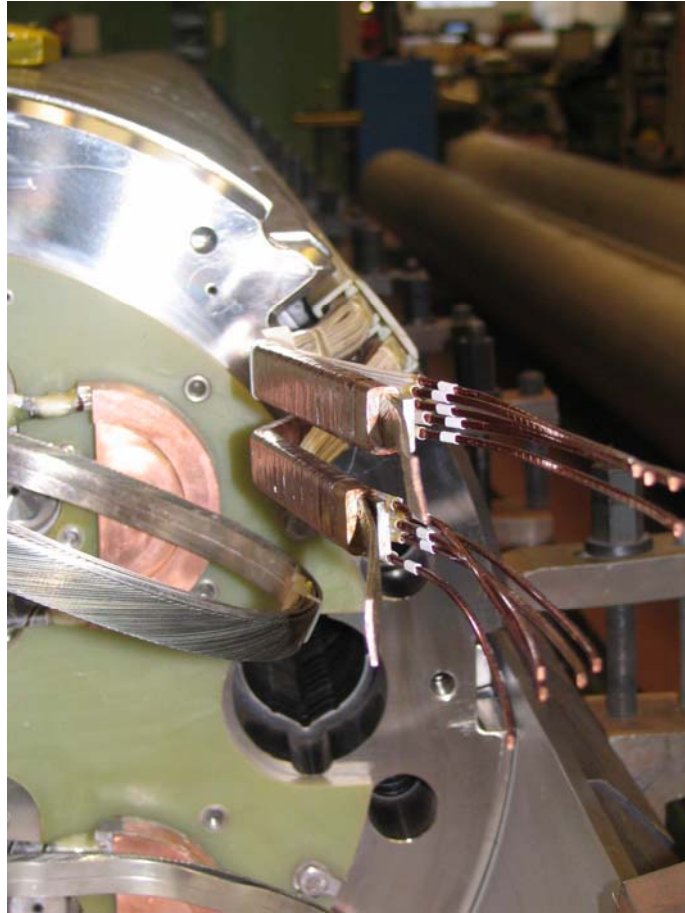
Bad shaping
