the  
**Large  
Hadron  
Collider**  
project

**LHC-MB-TP-0011**

# REQUIREMENTS FOR THE COLD BORE TUBE TO COLLAR FLANGE ("COLLERETTE") FILLET WELD OF THE LHC DIPOLE AND QUADRUPOLE COLD MASSES FOR MANUFACTURERS

## CATALOGUE OF TYPICAL DEFECTS AND CORRECTIVE ACTIONS

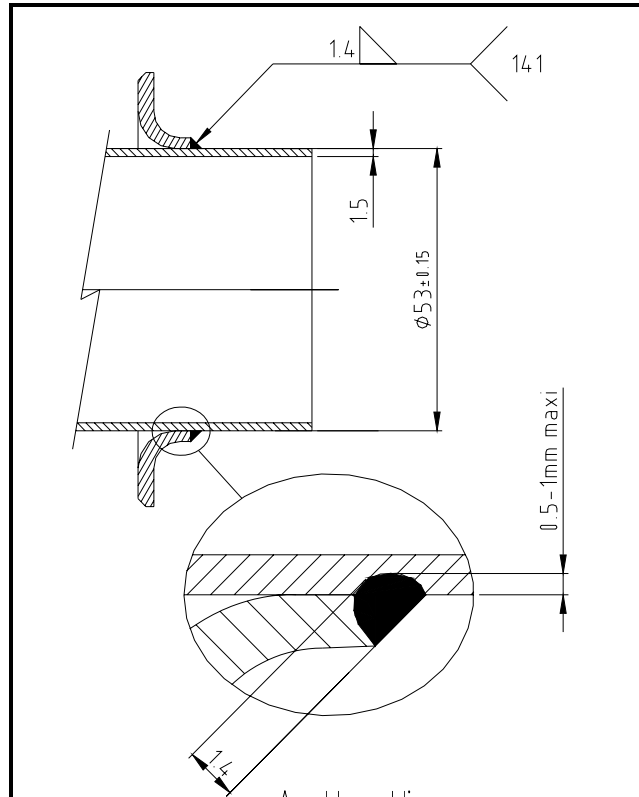
**Figure 1:** Dimensional requirements for the fillet weld

The required area cross-section of the weld and the allowed penetration are reminded in Figure 1.

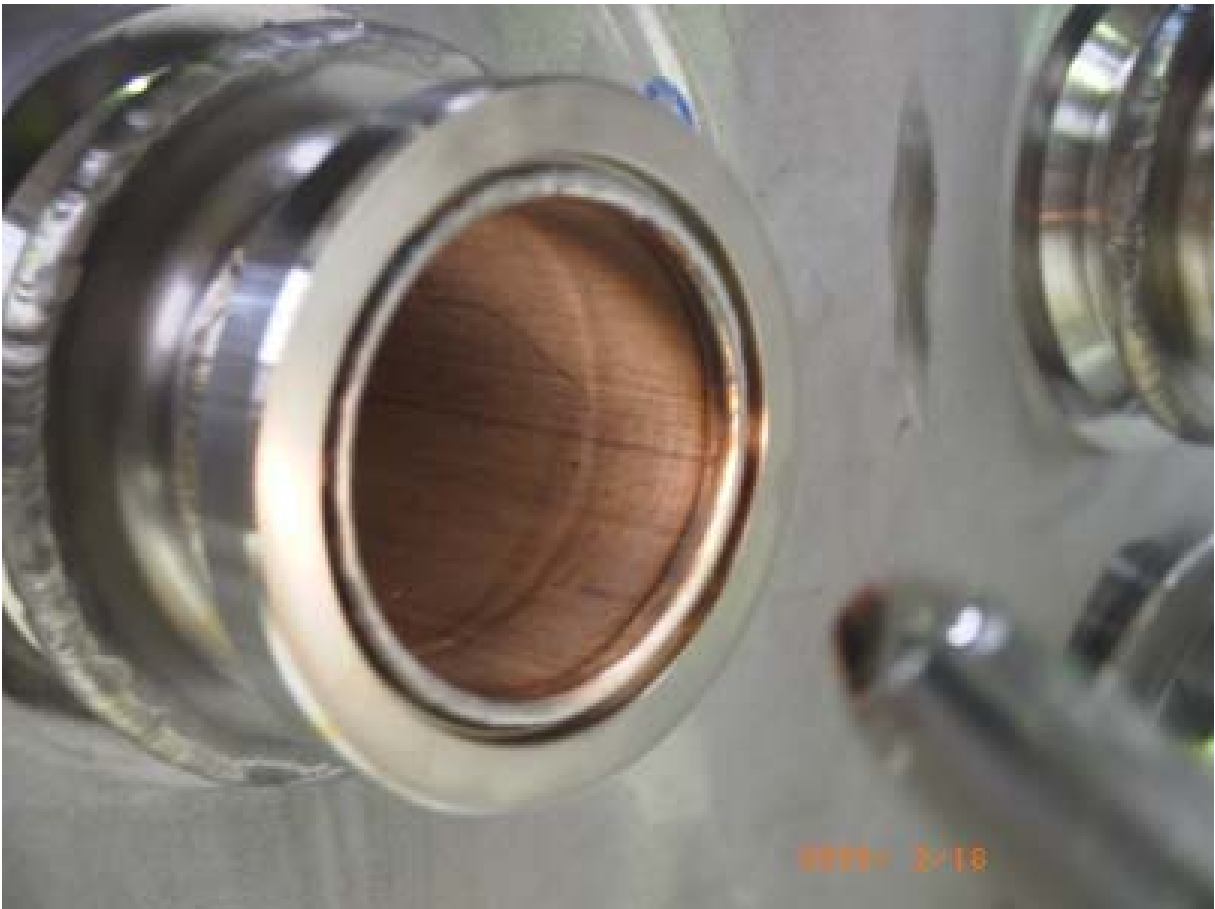
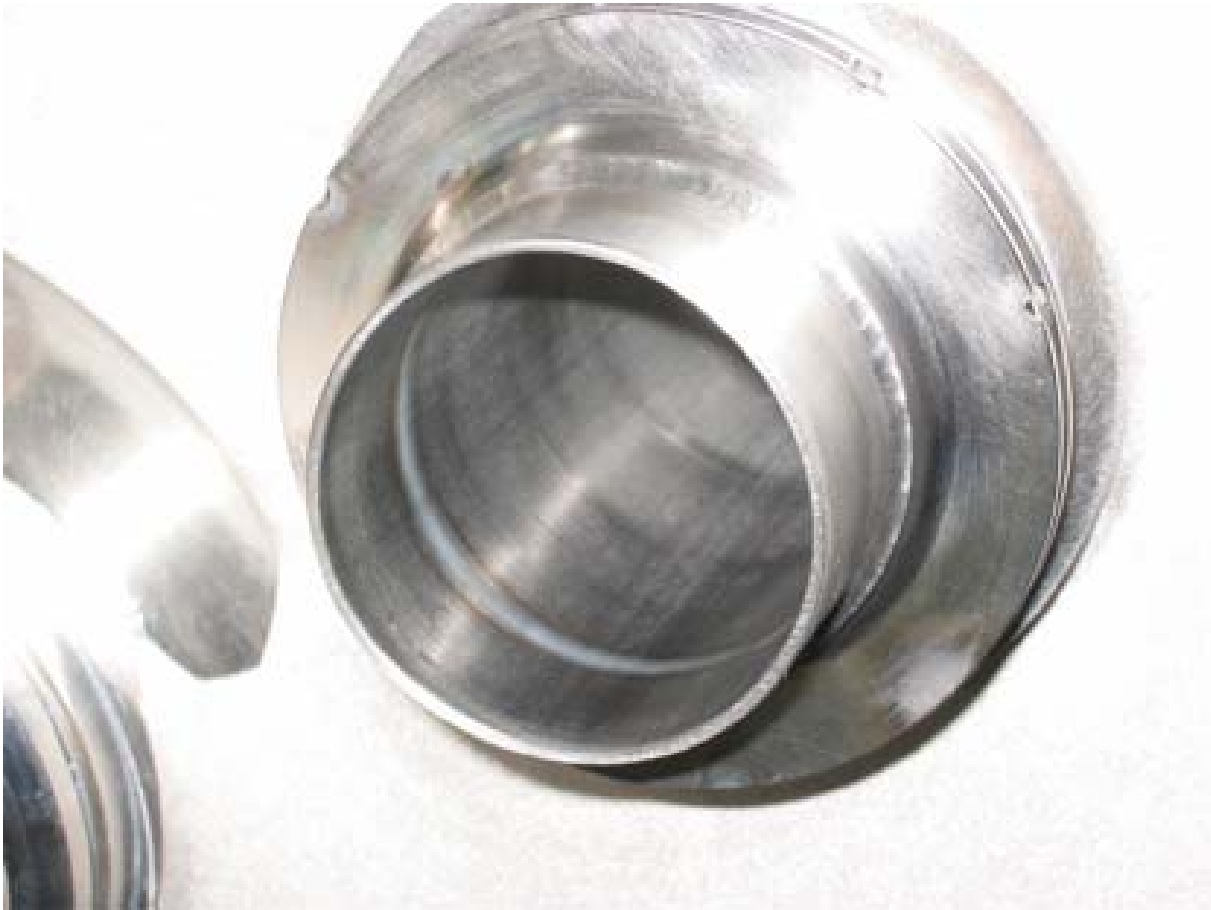
Figures 2 & 3 below show a satisfactory weld, without brushing.

Figure 2: C.b.t. to collerette weld, free of defect

Figure 3: C.b.t. to collerette weld, free of defect

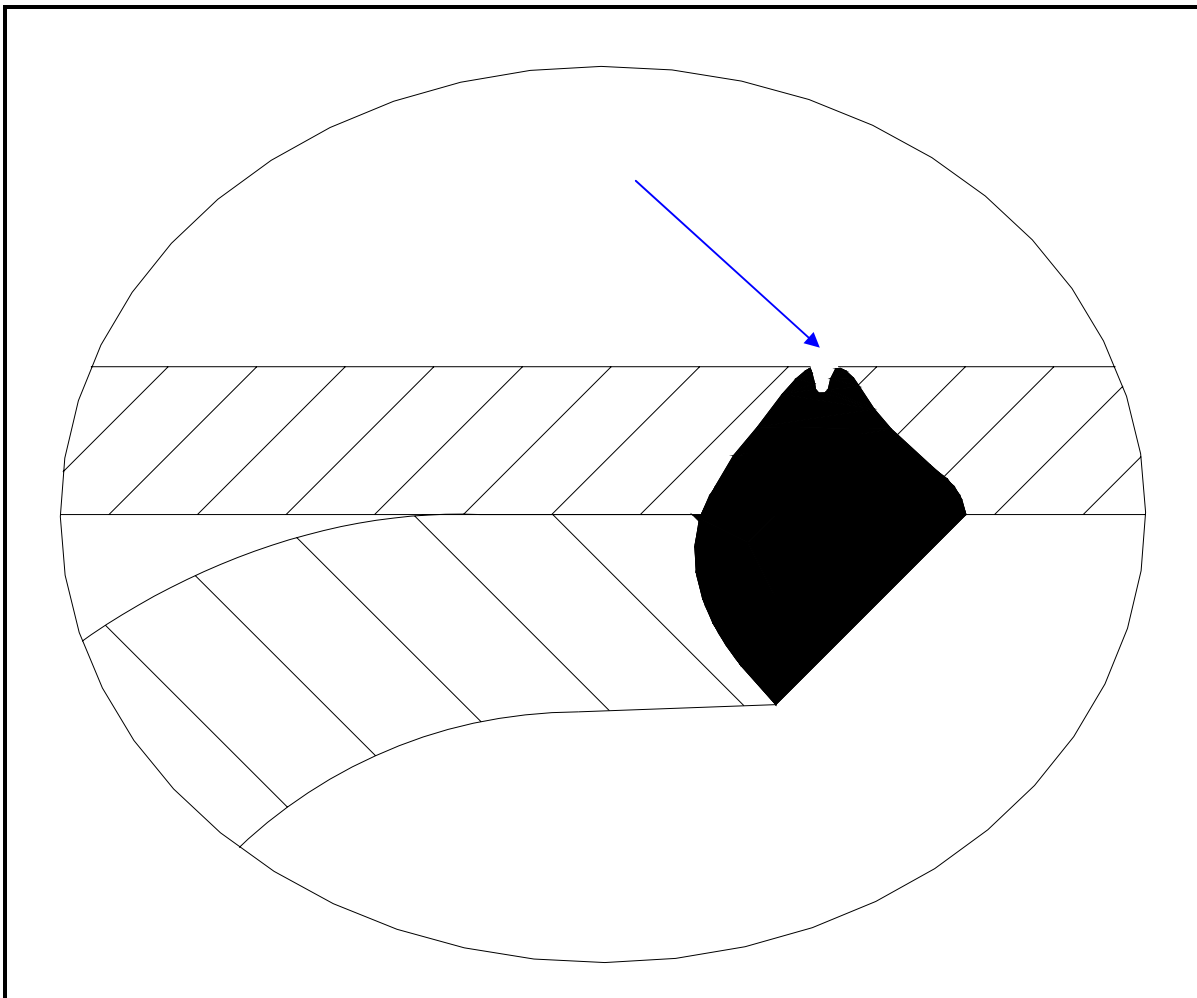
A root concavity is a shallow groove due to the shrinkage of a (butt) weld at the root side.

This imperfection is referred to as defect N°515 according to the international standard ISO 6520-1, 1998.

Figure 4: Root concavity – Defect N°515

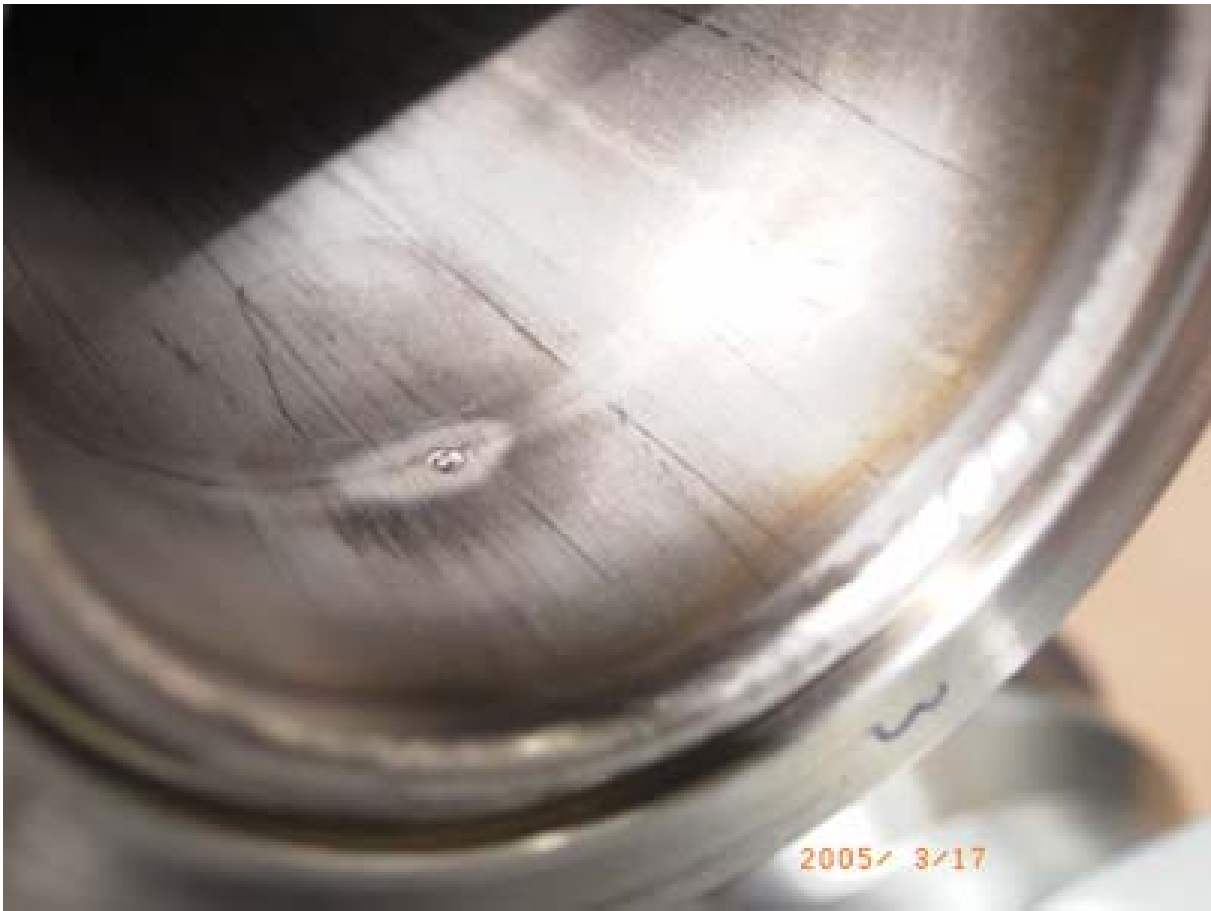
Figure 5: Root concavity – Defect N°515

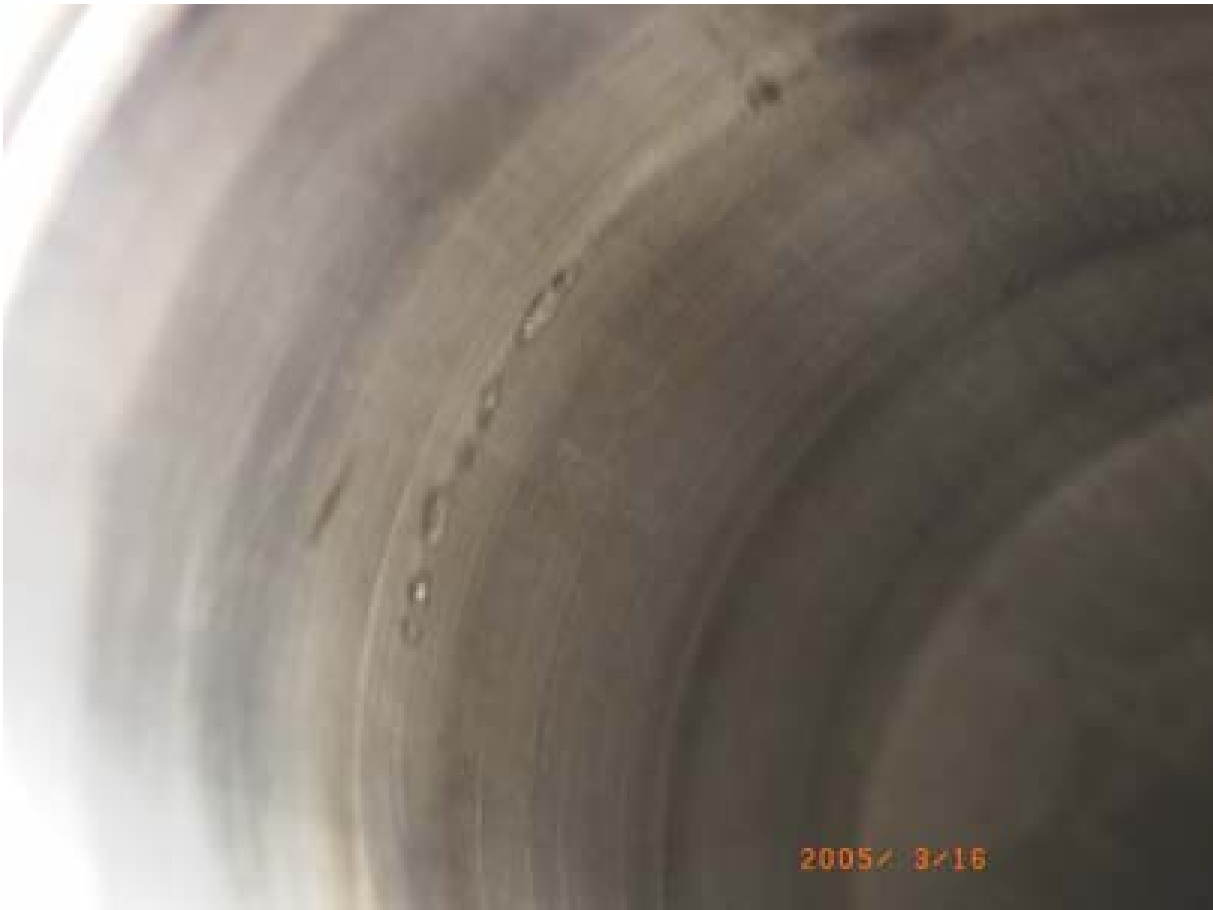
Figure 6: Root concavity – Defect N°515

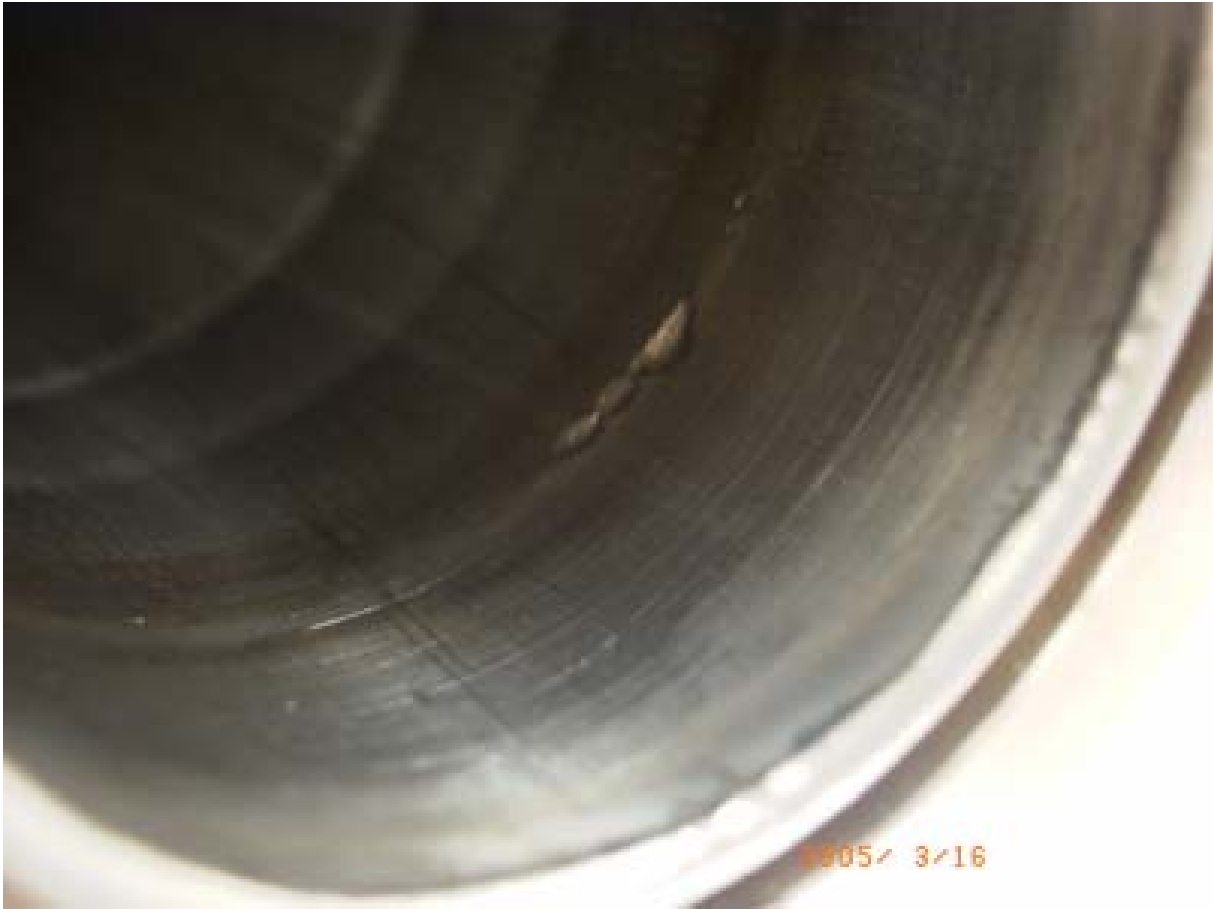
Figure 7: Root concavity – Defect N°515

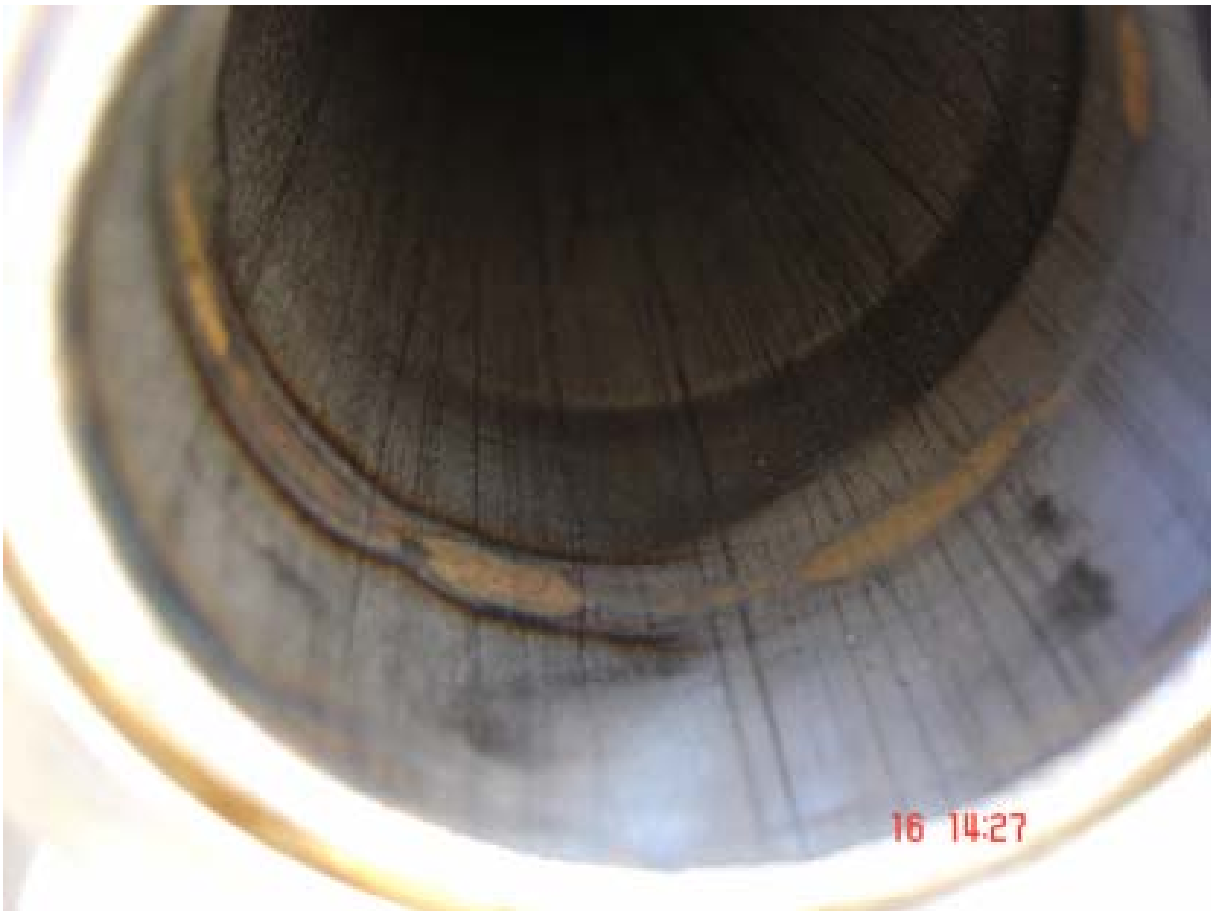
Figure 8: Corrosion

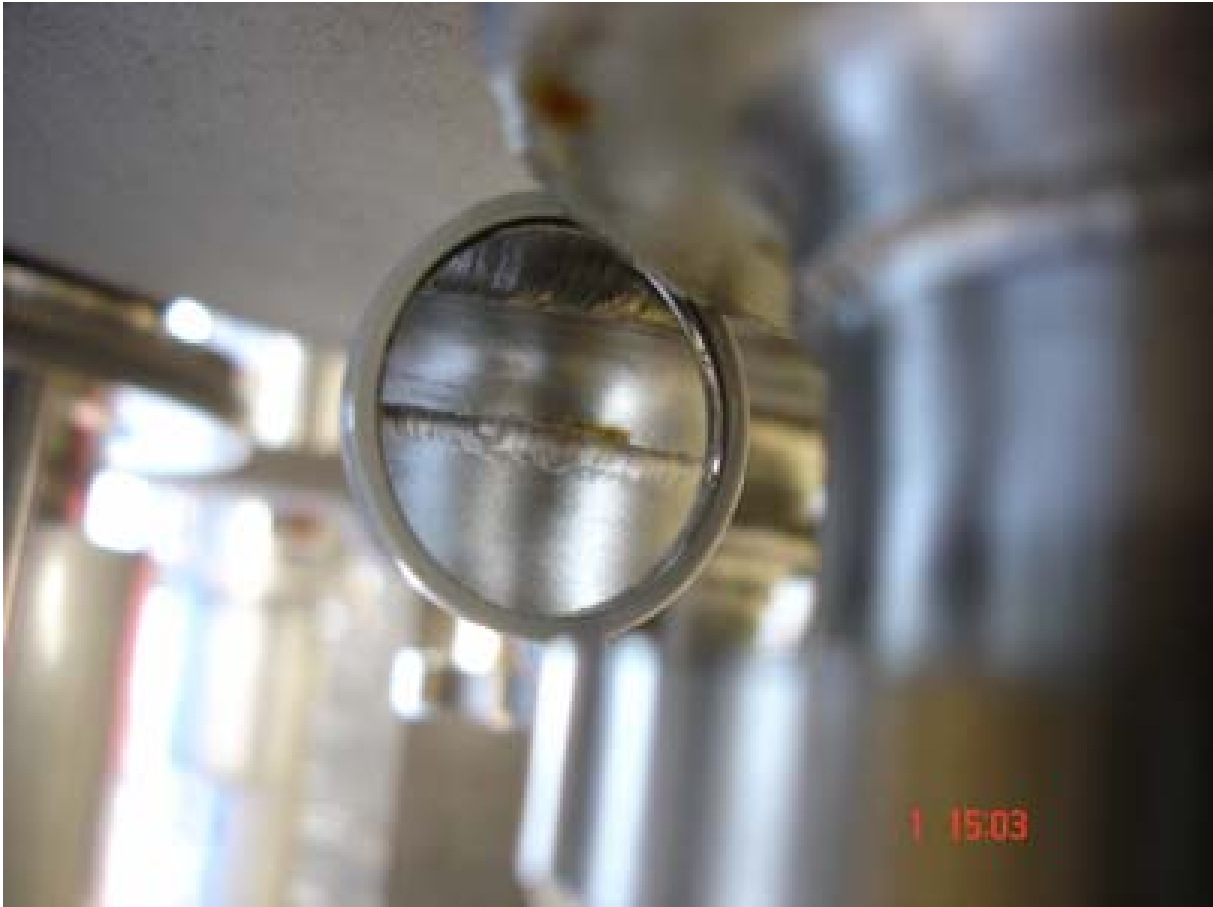
Figure 9: Corrosion

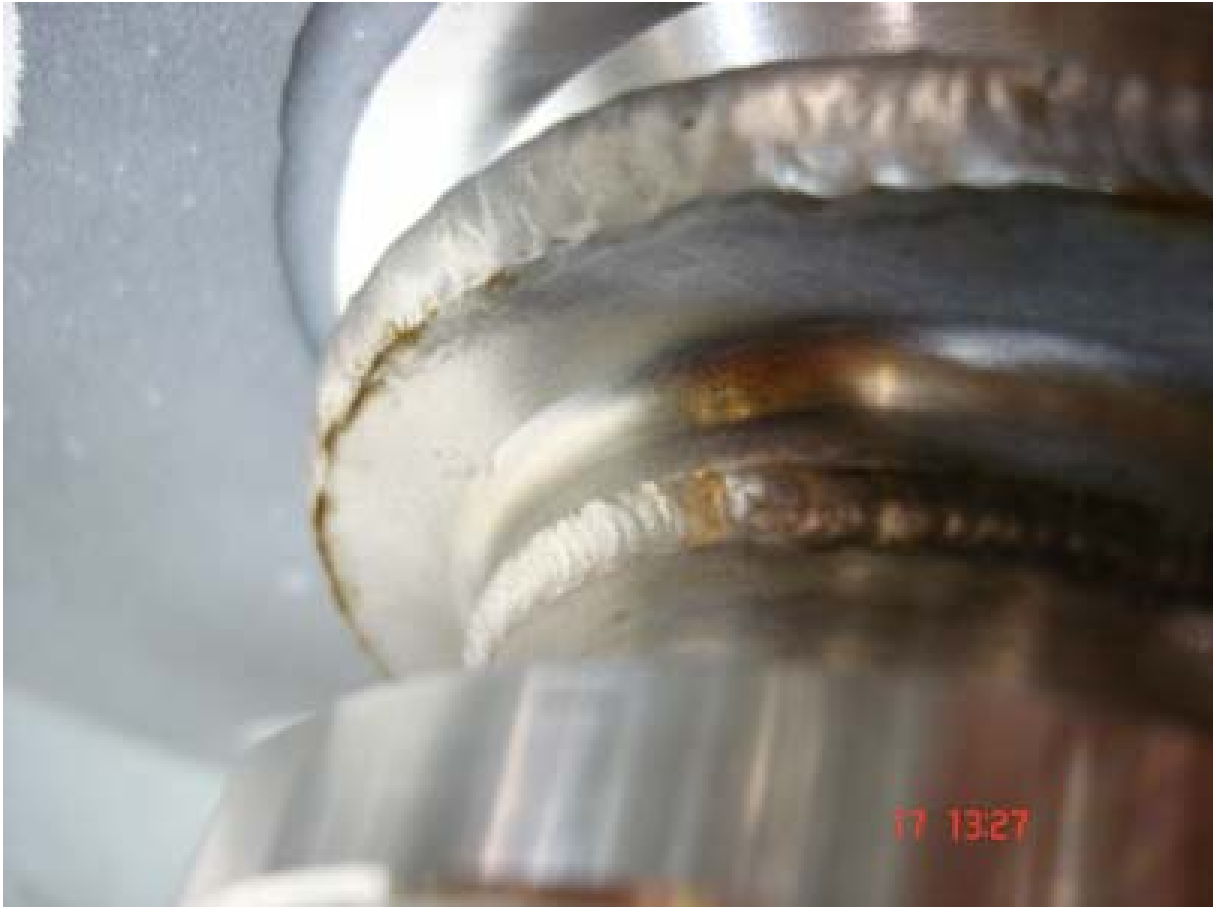
Figure 10: Corrosion

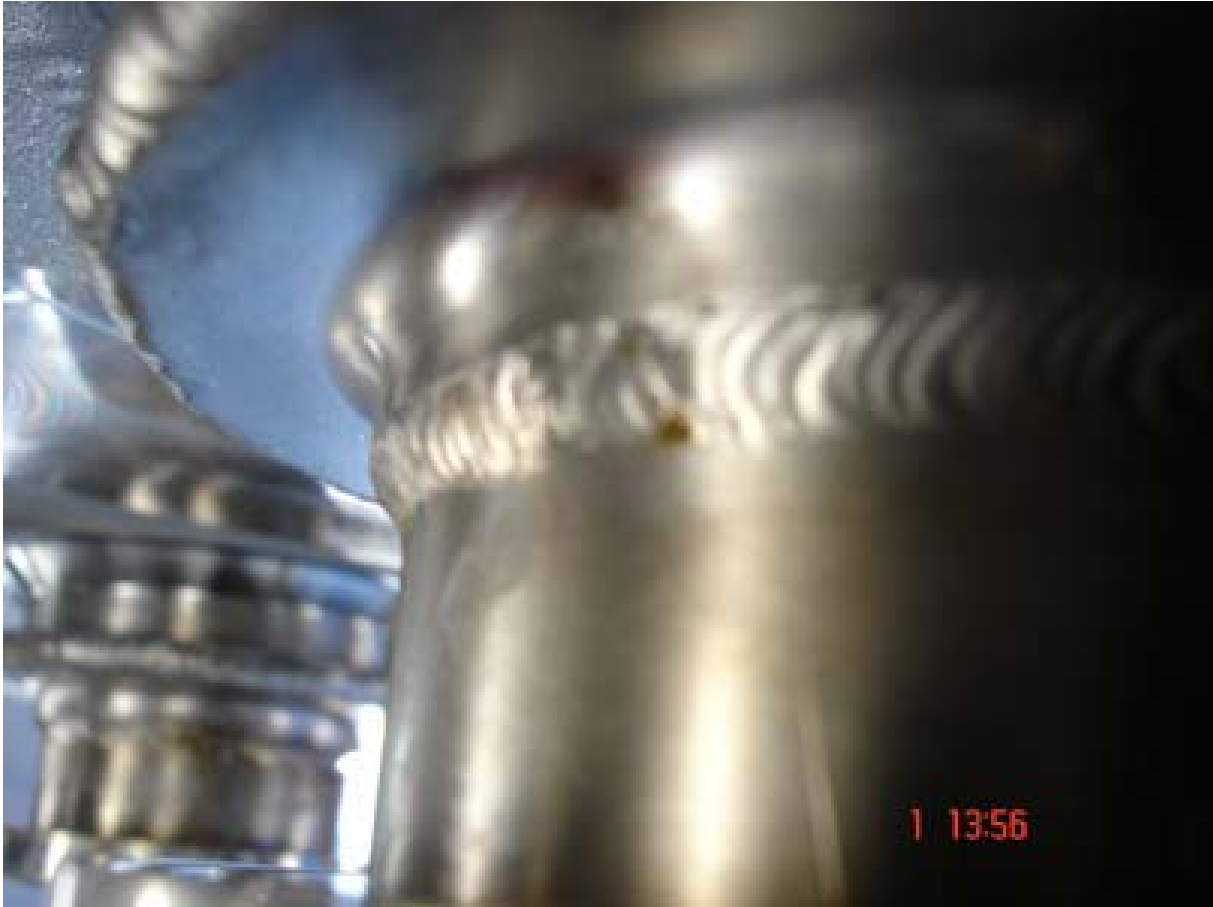
Figure 11: Corrosion

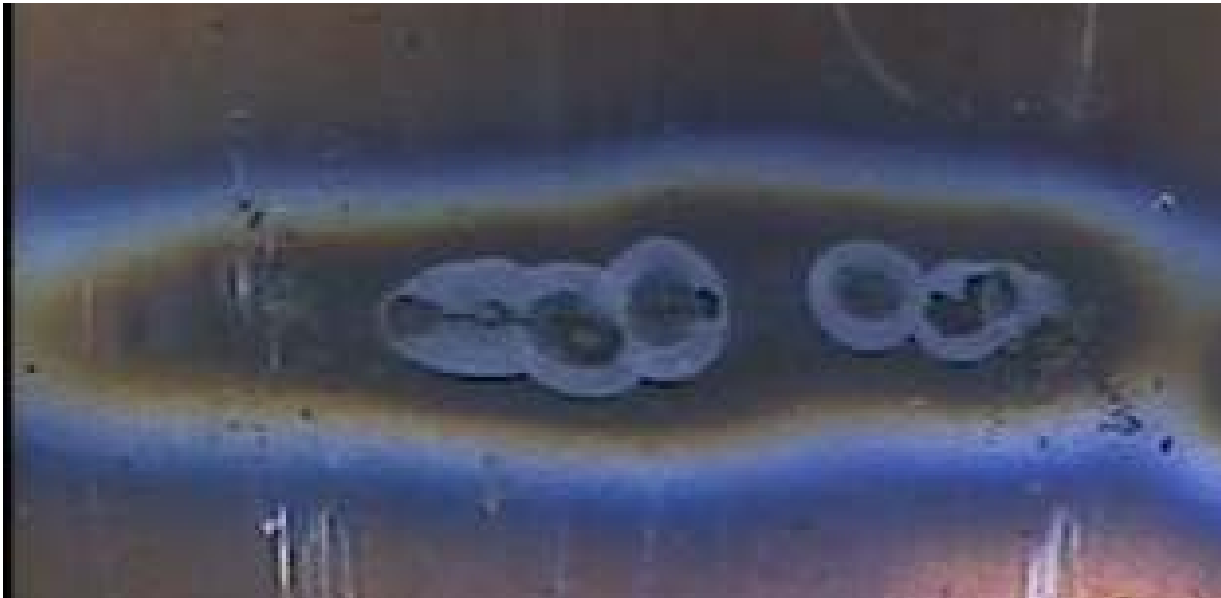
Root porosity is a spongy formation at the root of a weld due to bubbling of the weld metal at the moment of the solidification.

This imperfection is referred to as defect N°516 according to the international standard ISO 6520-1, 1998.

Figure 12: Root porosity – Defect N°516

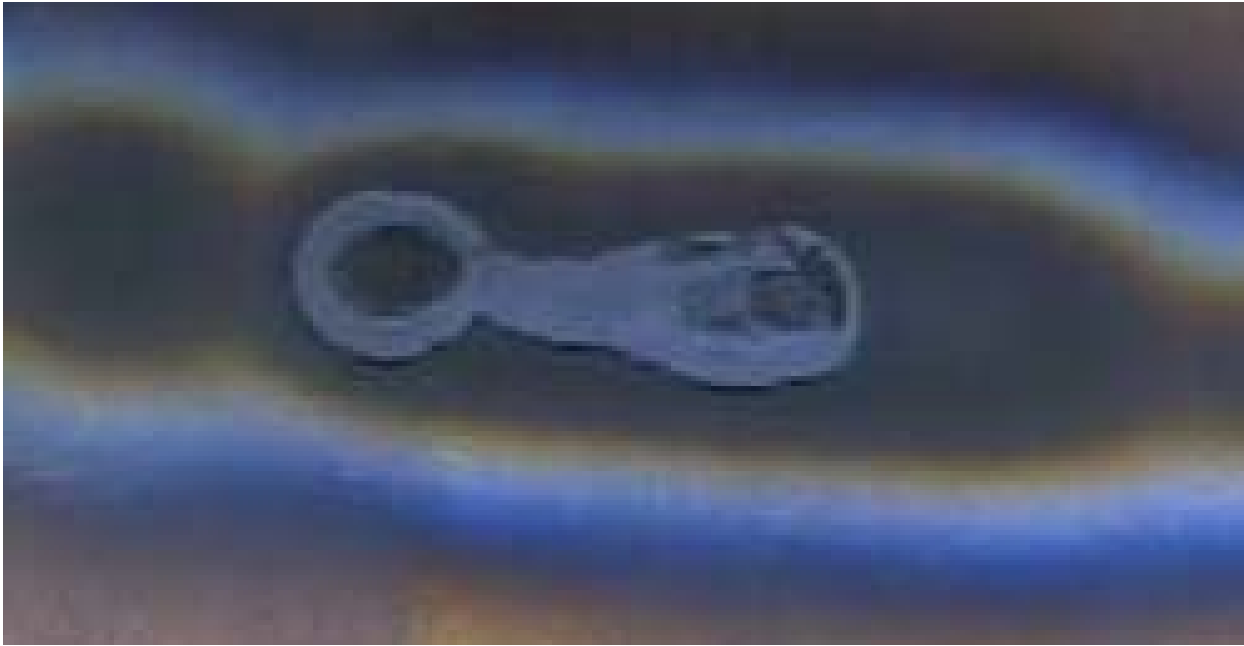
Figure 13: Root porosity – Defect N°516

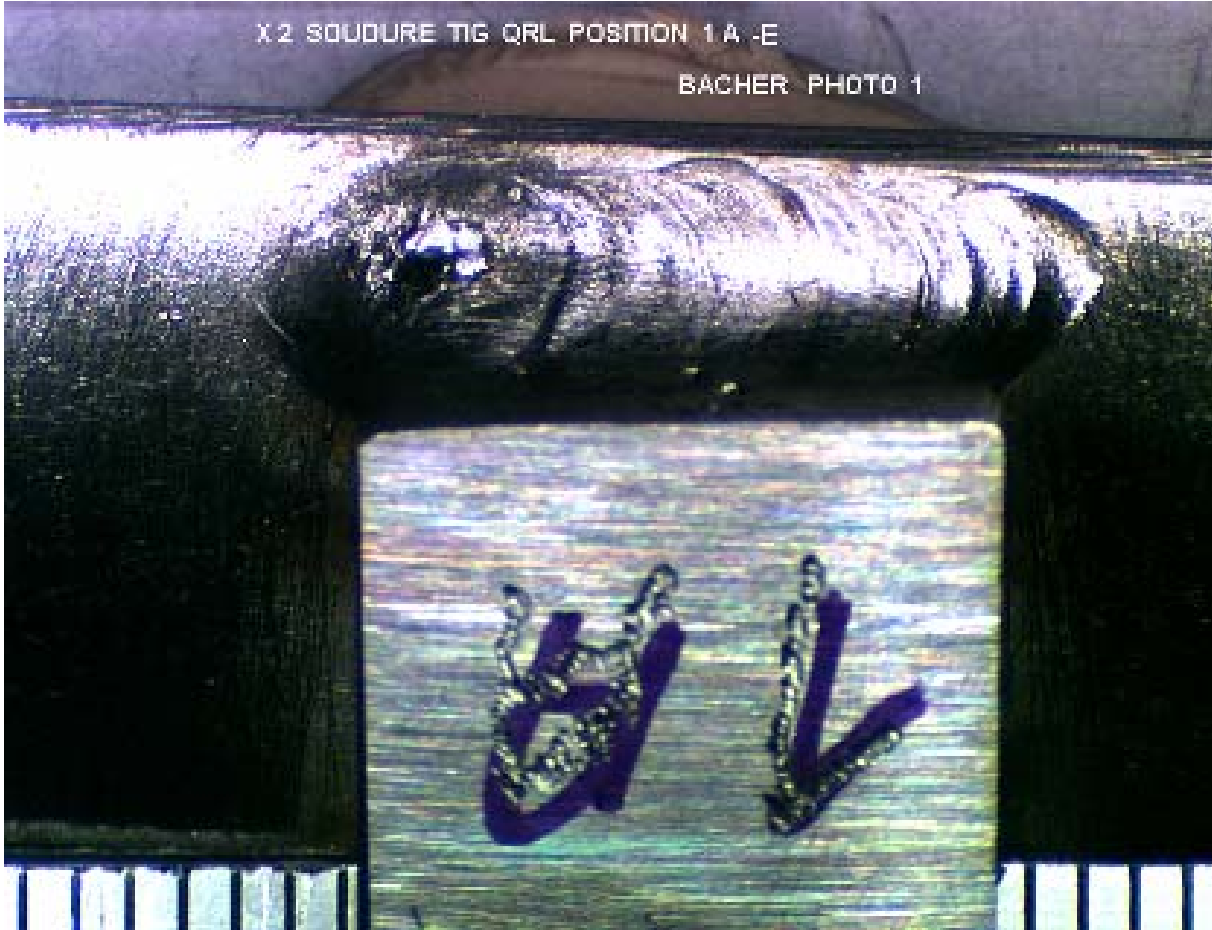
Crater pipe is also an open crater reducing the cross-section of the weld, in this case it is called end crater pipe.

This imperfection is referred to as defect N°2025 according to the international standard ISO 6520-1, 1998.

The pictures 14 and 15 showing such defects were not taken from magnet cold masses as, so far, this kind of defects has never been observed [3].

Figure 14: End crater pipe – Defect N°2025

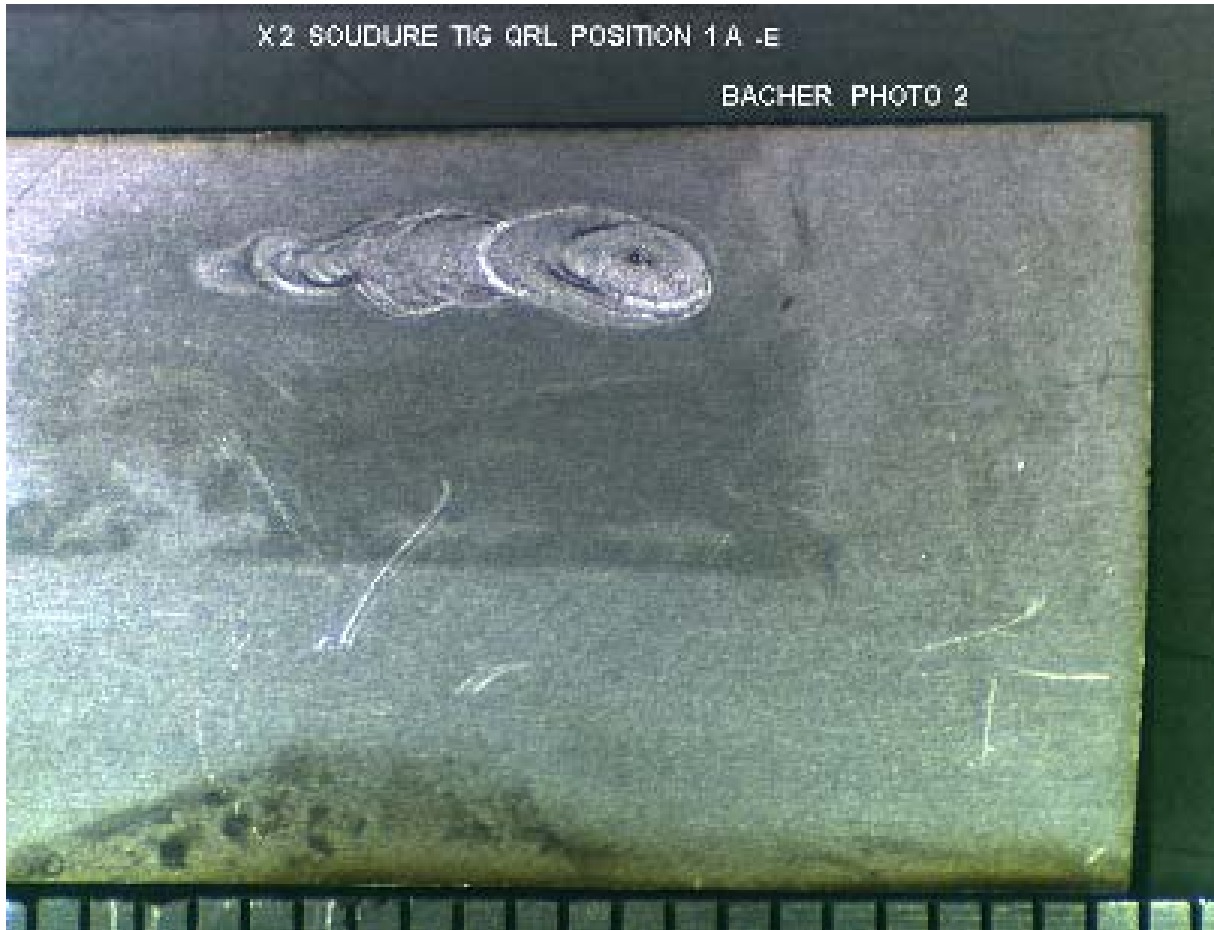
Figure 15: End crater pipe – Defect N°2025

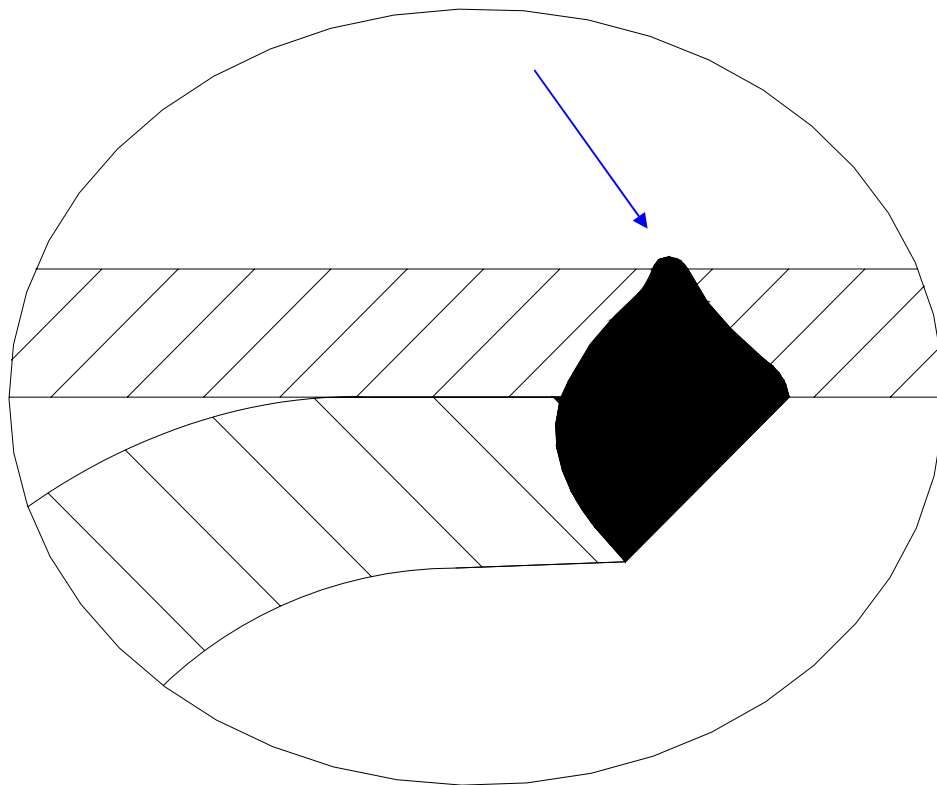
The requirement for a fillet weld is normally defined by his area cross section. In order to satisfy the specific need of the LHC machine, a penetration depth inside the cold bore tube was added representing a maximum of 2/3 of the section tube (Figure 1).

In consequence, this imperfection in our case is not refered in the international standard. Nevertheless, it could be compared to a melt through, defect N°5043 according to the international standard ISO 6520-1, 1998.

Figure 16: Full penetration and oxidation

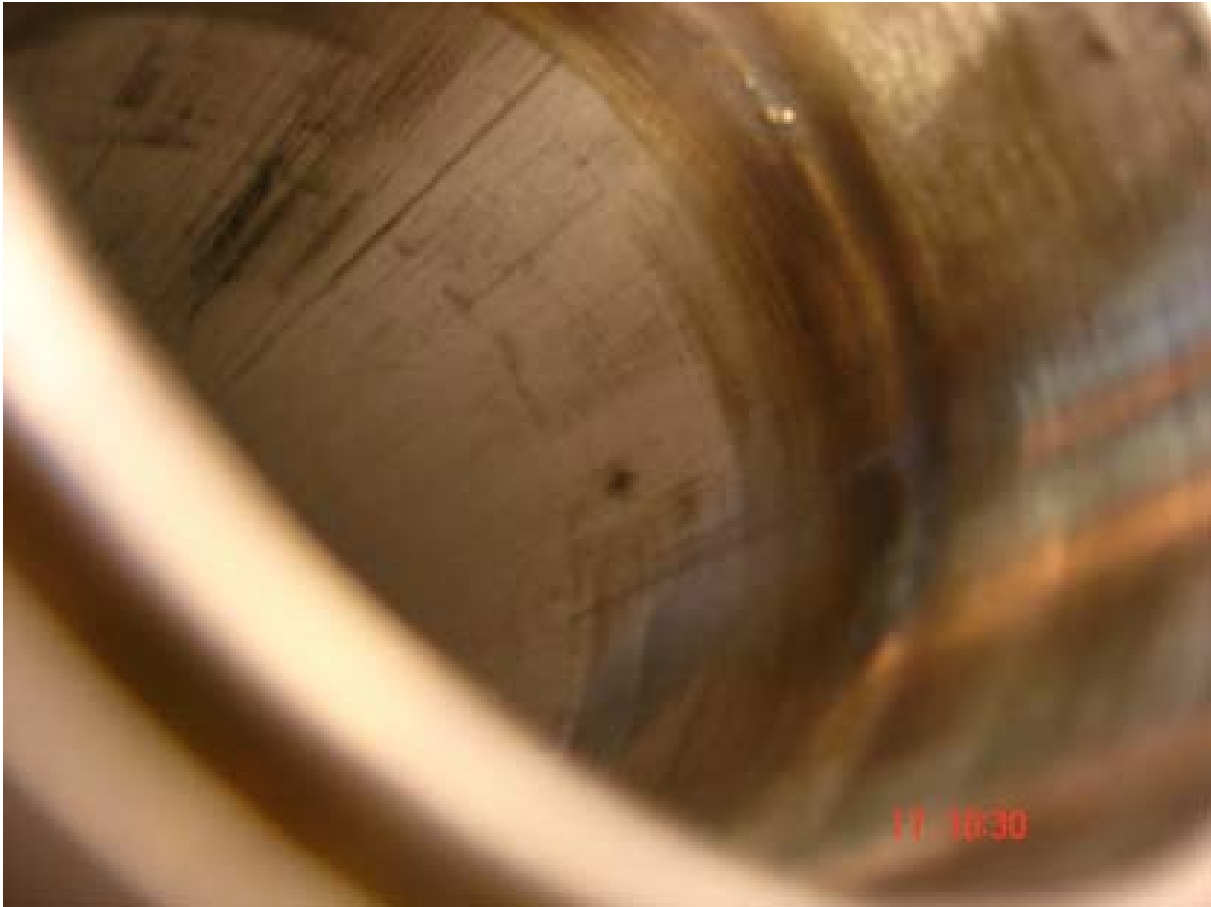
Figure 17: Full penetration and oxidation

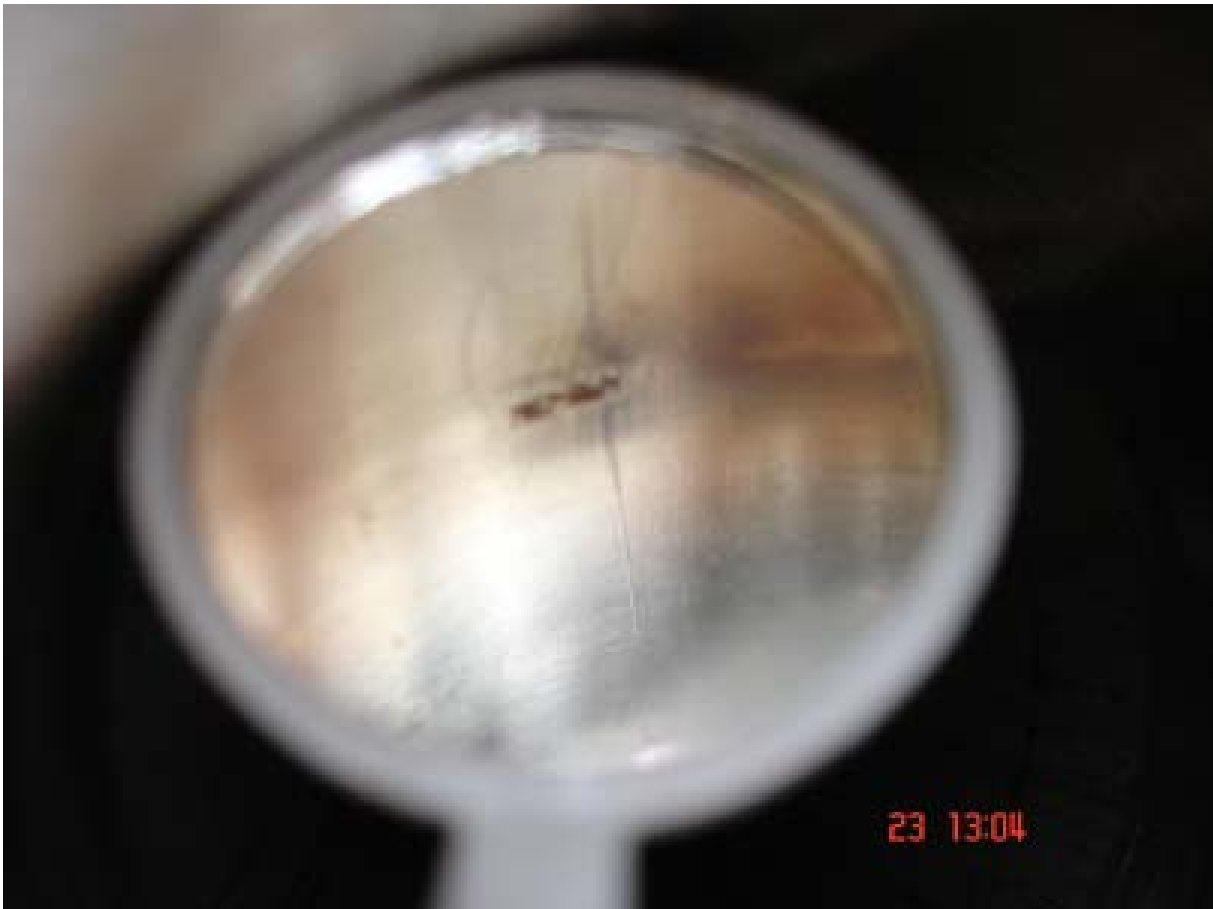
Figure 18: Full penetration and oxidation

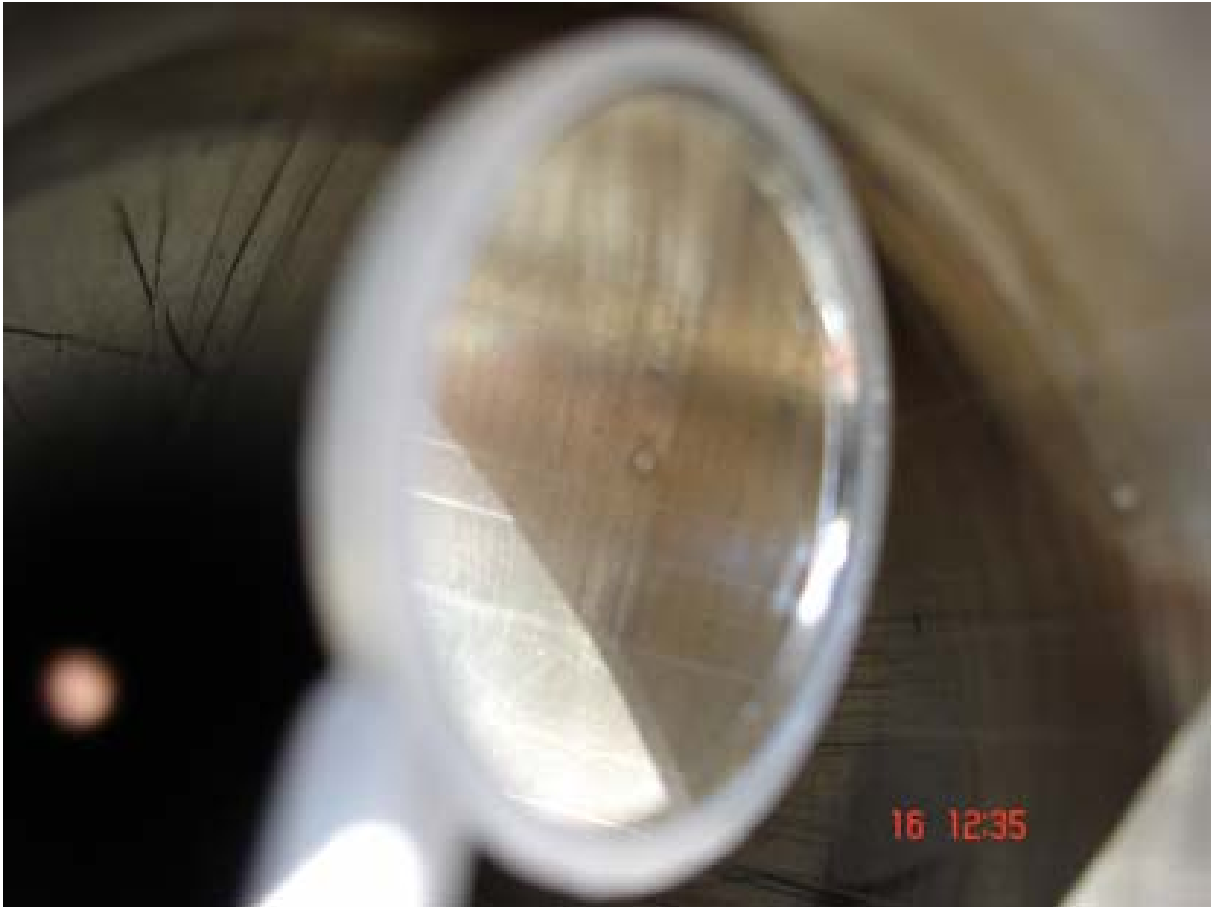
Figure 19: Full penetration

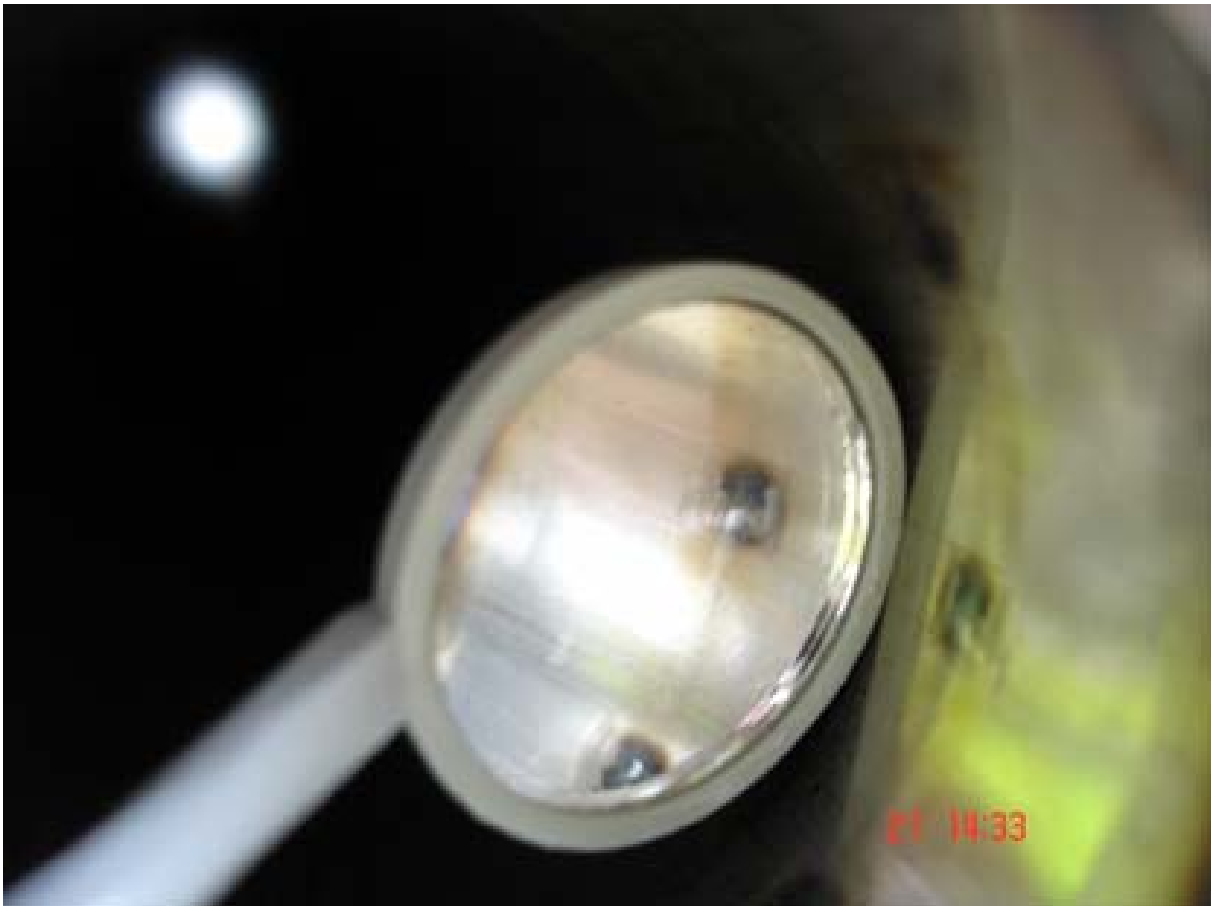
Scaled surface is an heavily oxidized surface in the weld zone.

This imperfection is referred to as defect N°613 according to the international standard ISO 6520-1, 1998.

Figure 20: Scaled surface – Defect N°613

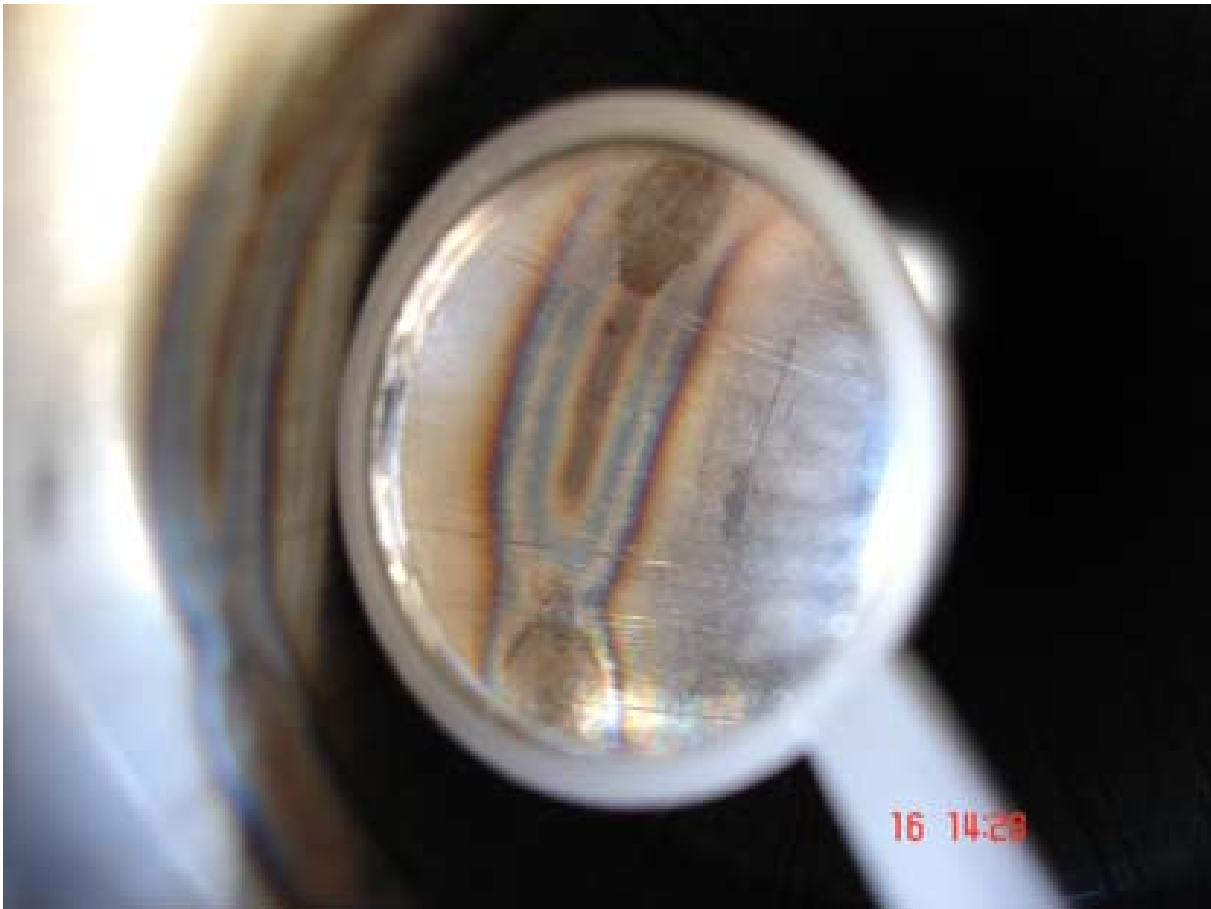
Figure 21: Scaled surface – Defect N°613
