the  
**Large  
Hadron  
Collider**  
project

**LHC-MB-TP-0011**

# REQUIREMENTS FOR THE COLD BORE TUBE TO COLLAR FLANGE ("COLLERETTE") FILLET WELD OF THE LHC DIPOLE AND QUADRUPOLE COLD MASSES FOR MANUFACTURERS

## CATALOGUE OF TYPICAL DEFECTS AND CORRECTIVE ACTIONS

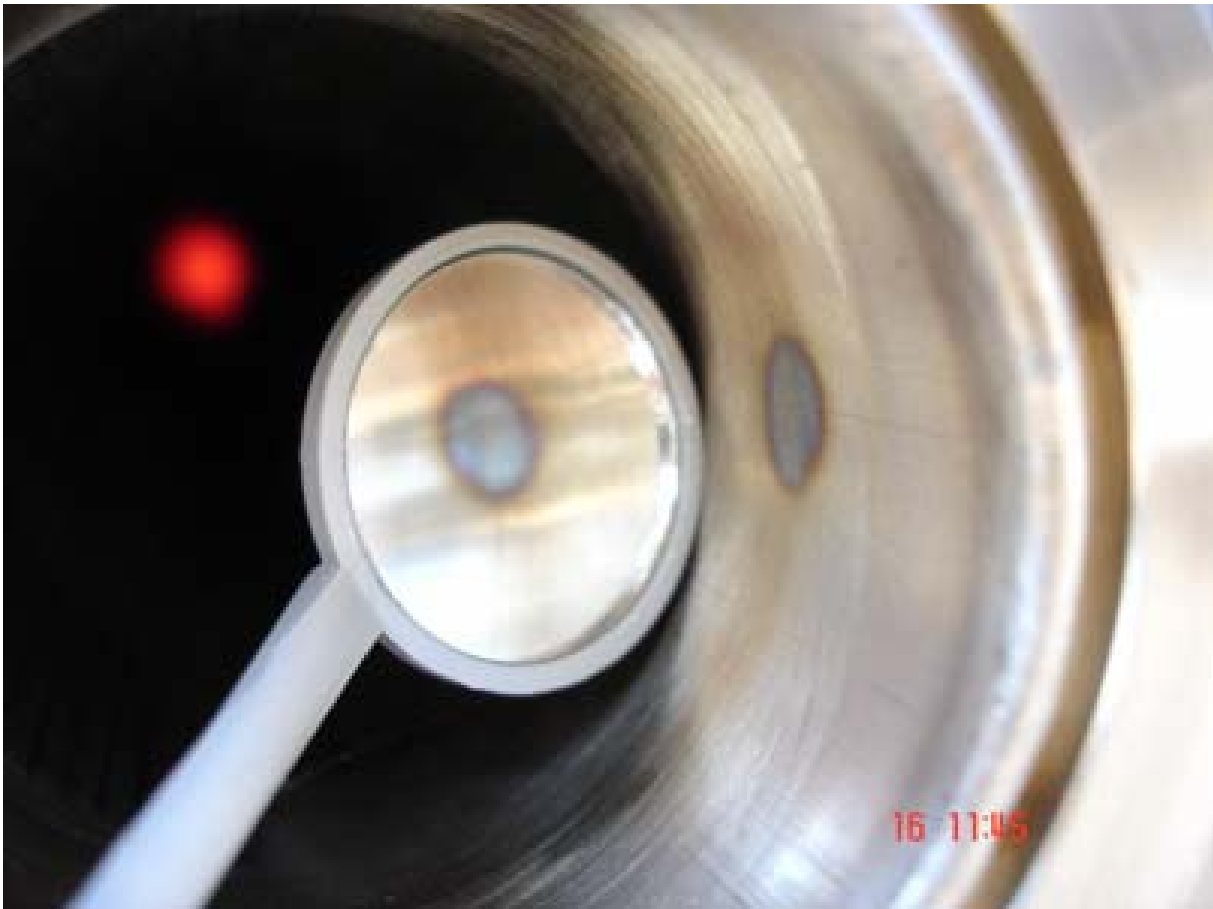
Figure 22: Scaled surface – Defect N°613

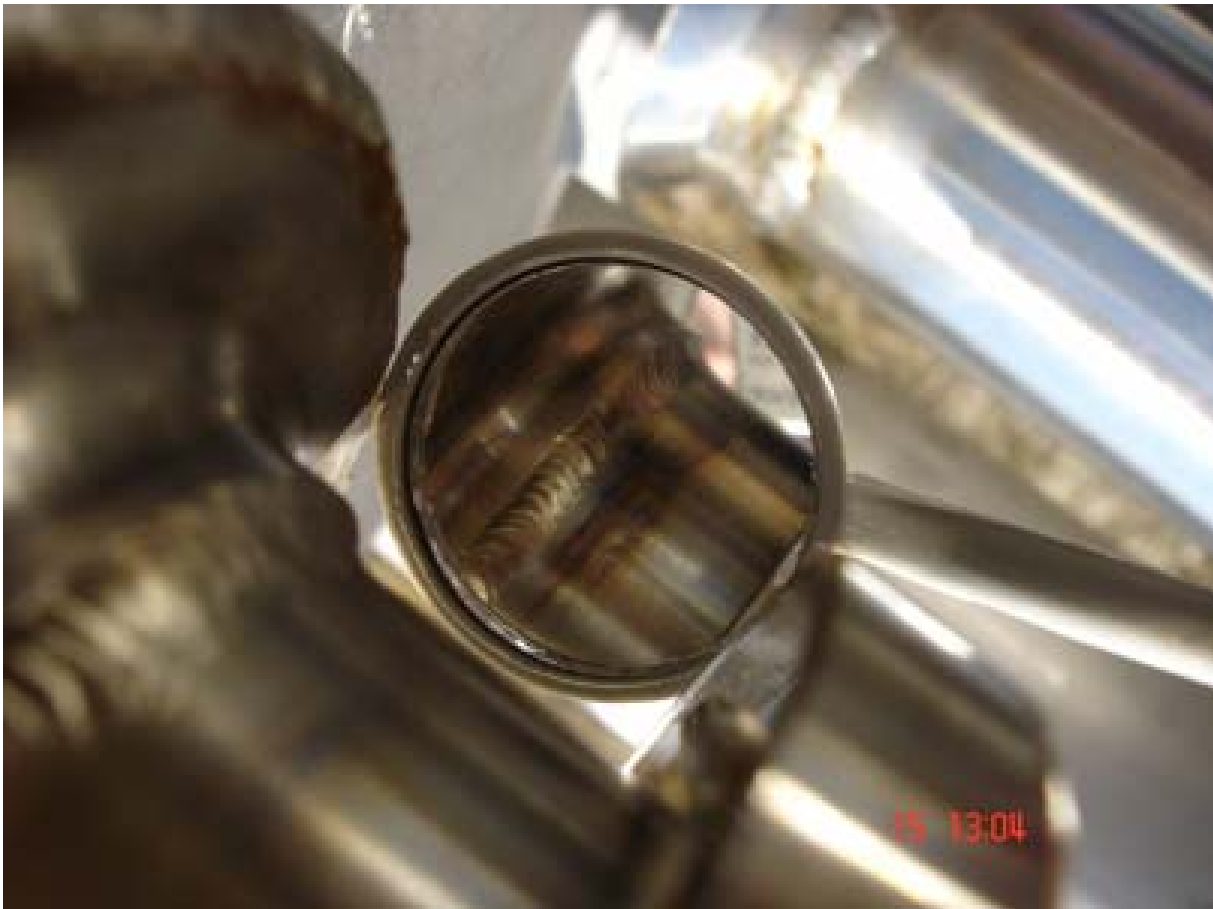
Figure 23: Scaled surface – Defect N°613

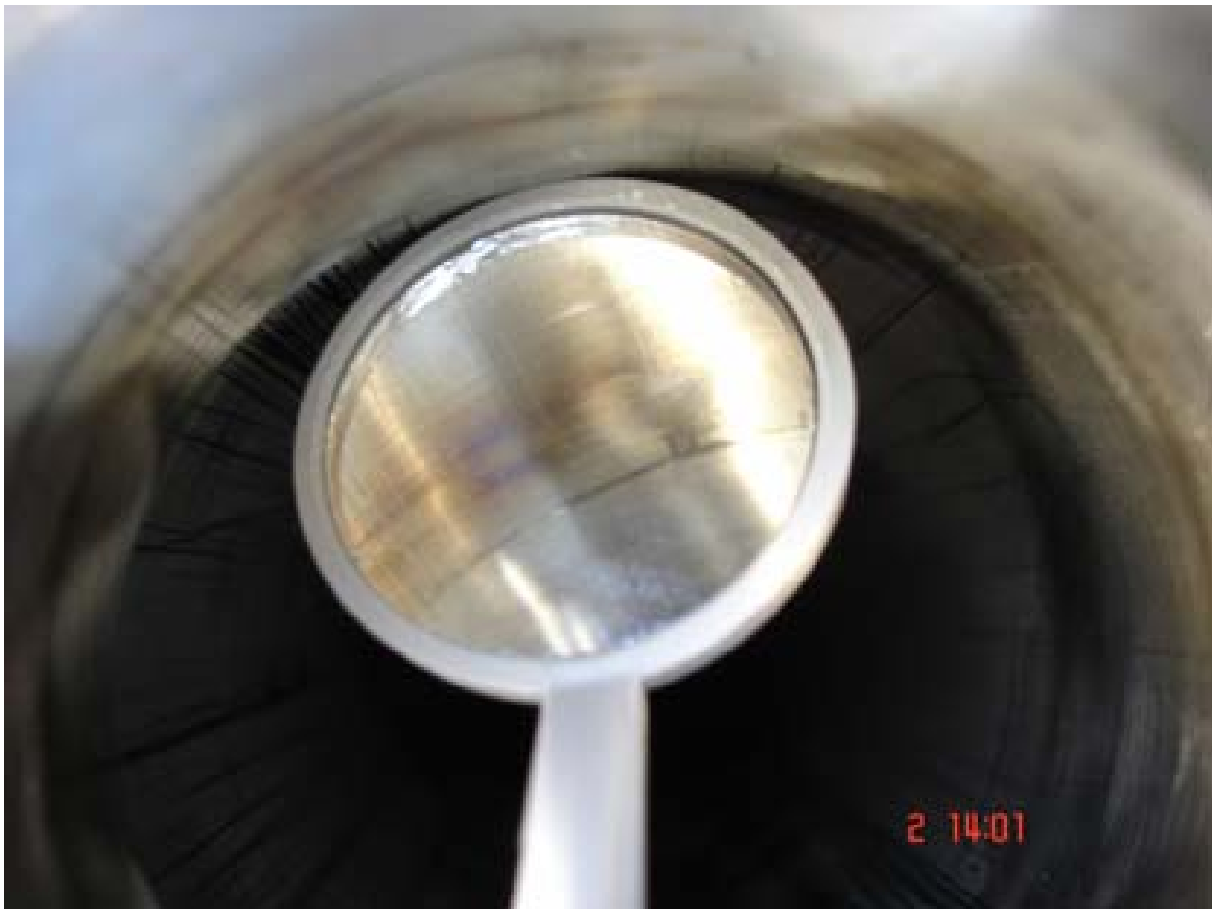
A temper color is a lightly oxidized surface in the weld zone, e.g. in stainless steel.

This imperfection is referred to as defect N°610 according to the international standard ISO 6520-1, 1998.

Figure 24: Temper color – Defect N°610

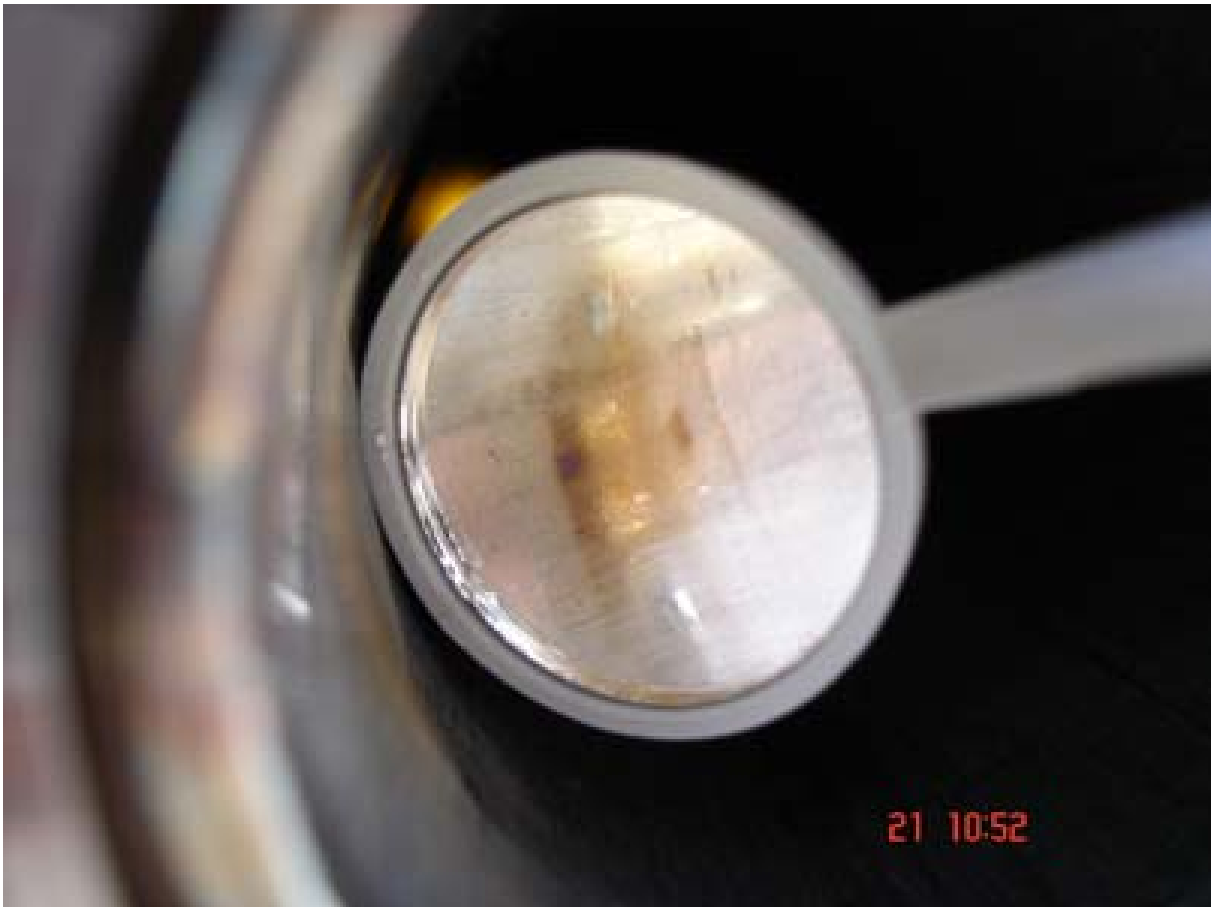
Figure 25: Temper color – Defect N°610
