### **LHC: Yoke laminations from FSG with oxidation**

Here below is reported the list of all the batches received from FSG showing severe oxidation, and for some of them also the relevant pictures have been enclosed. Some of these batches have been already stacked, cleaned and assembled into cold mass; some other are at ASG stacked but not yet cleaned and some other are at ORMET still to be stacked.

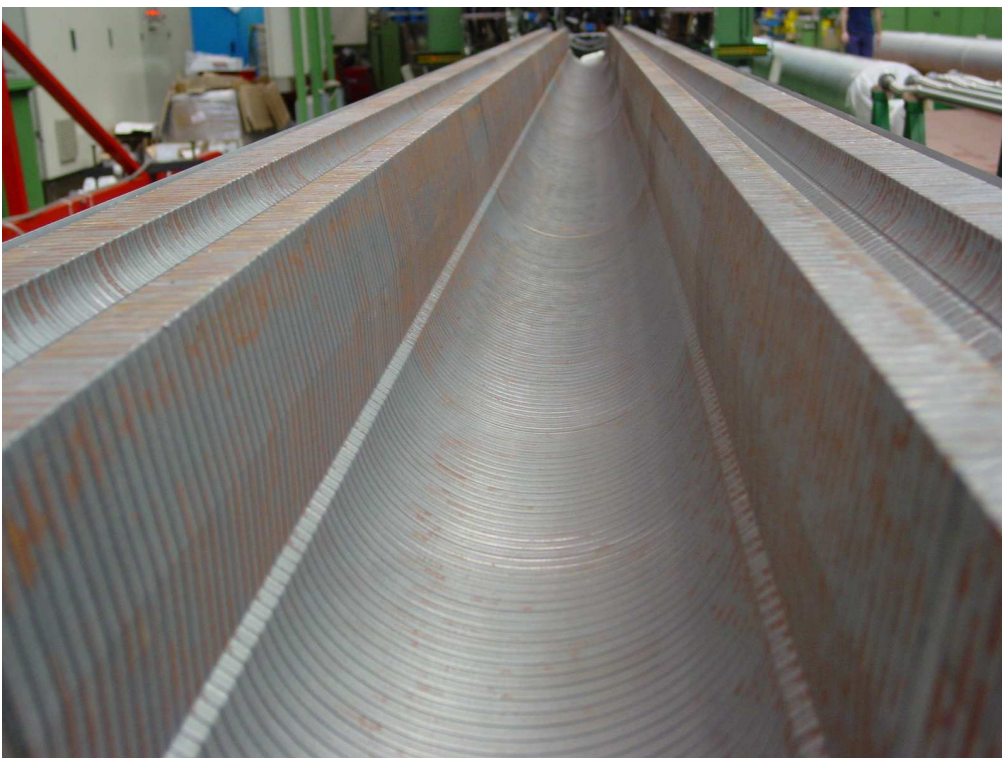
Lower Yoke (inner side)

For this two batches the oxidation was present but not severe and for this reason the yokes were cleaned (using scotch-brite) and then assembled. Here below are reported some photos about batch FSG529; the other one was almost in the same condition. In order to properly clean such yokes were necessary 5 hours of extra-works for each batch.

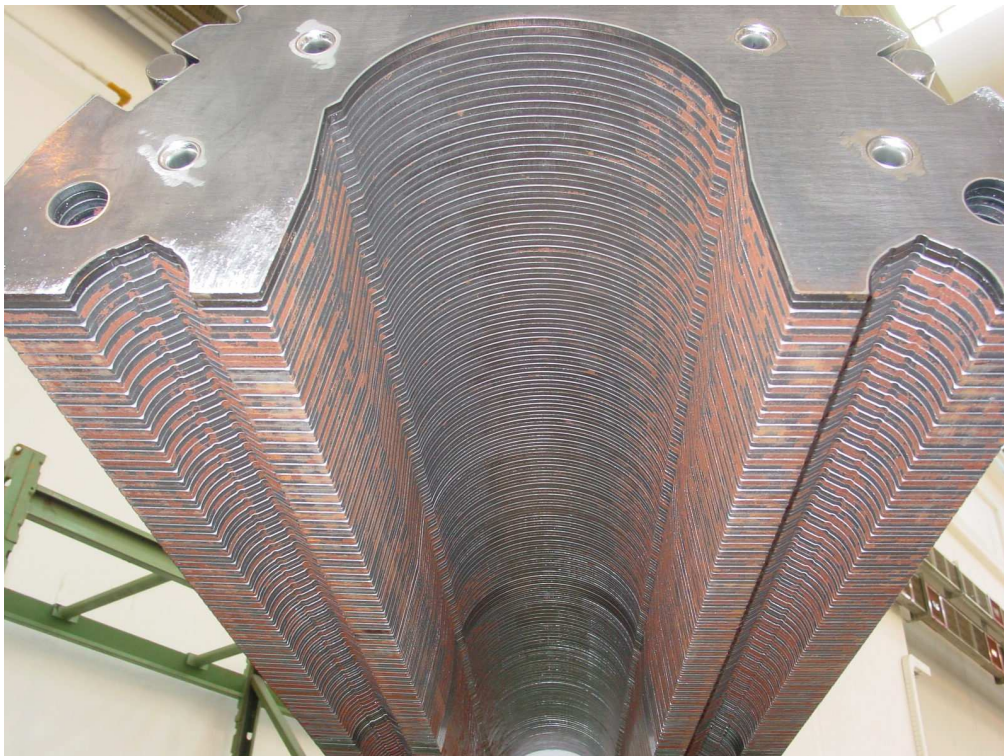
The batches already stacked and showing "light" oxidation which have to be cleaned before the assembly are five: FSG493, FSG501, FSG509, FSG510 and FSG524.

For this five batches the oxidation is present but not severe; the yokes have to be cleaned (using scotch-brite) and then assembled. Here below are reported some photos about batch FSG501; the other one was almost in the same condition. In order to properly clean such yokes will be necessary 8 hours of extra-works for each batch.

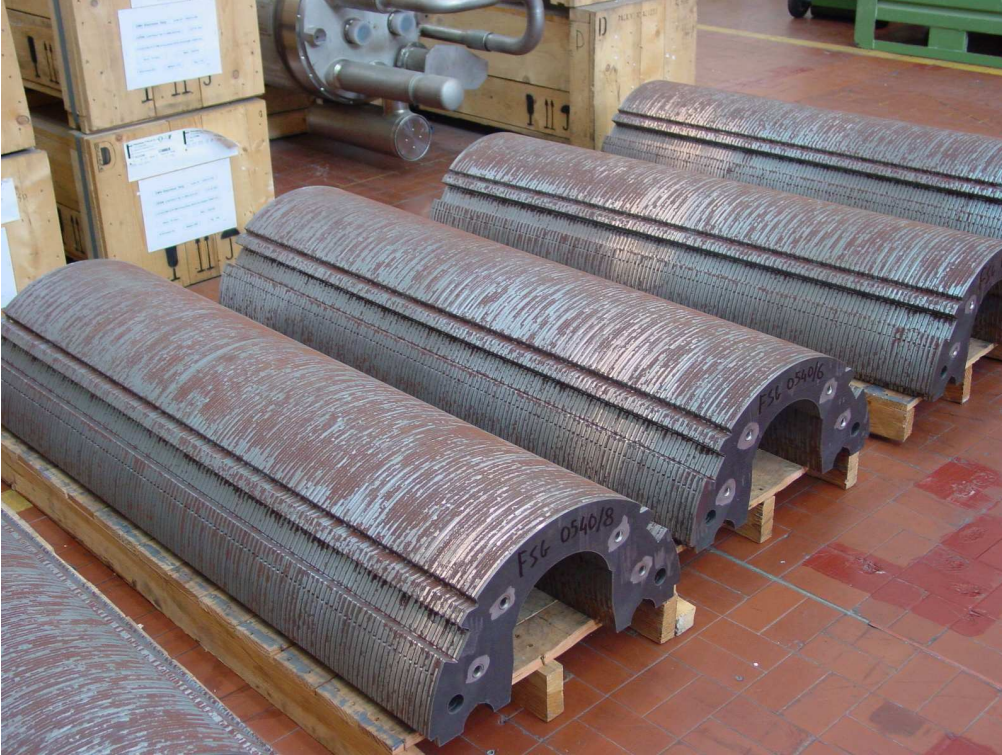
Batch FSG540

The batches already stacked and showing “severe” oxidation which have to be cleaned before the assembly are four: FSG530, FSG540, FSG549 and FSG550.

For this batches the oxidation is heavy; the yokes cleaning require brushing and a further action using scotch-brite. In order to properly clean such yokes will be necessary 1.5 hours/pack which means 24 hours of extra-works for each batch. Here below are reported some photos about batch FSG530 and FSG540; the other ones are in the same condition.

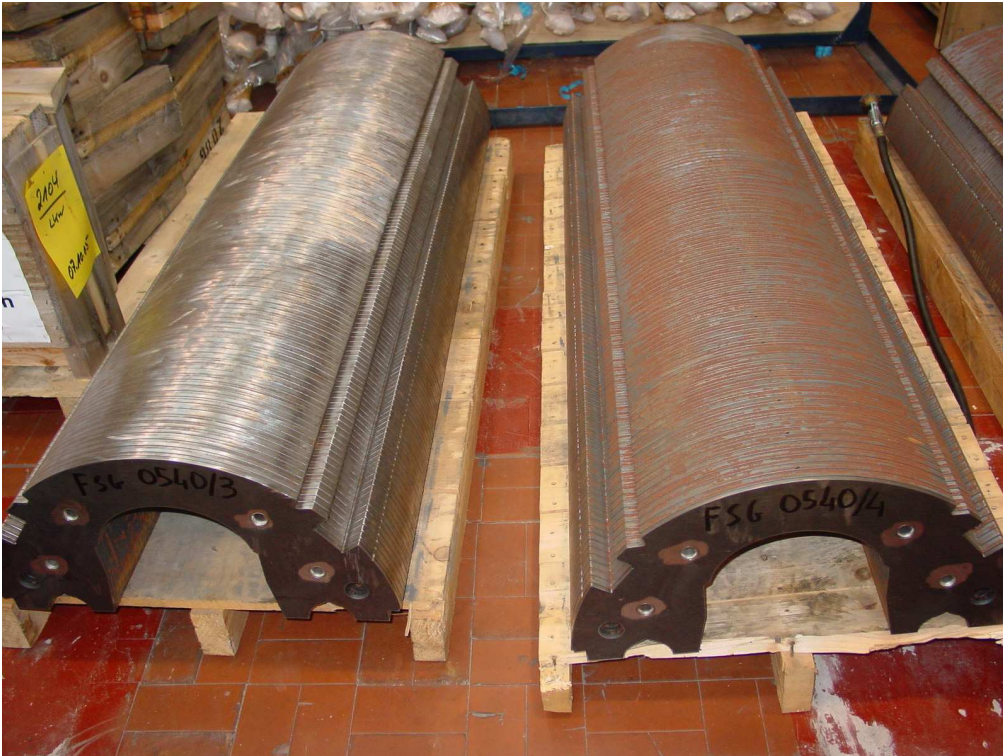
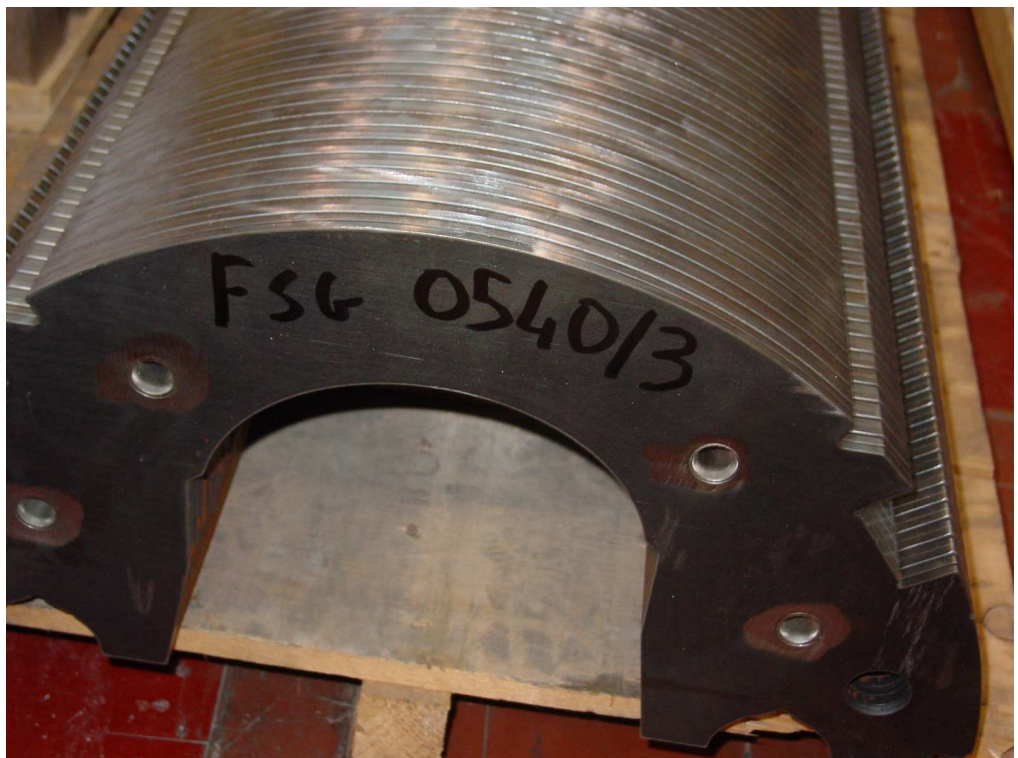
In the following photos are reported the result of the cleaning test on one pack.

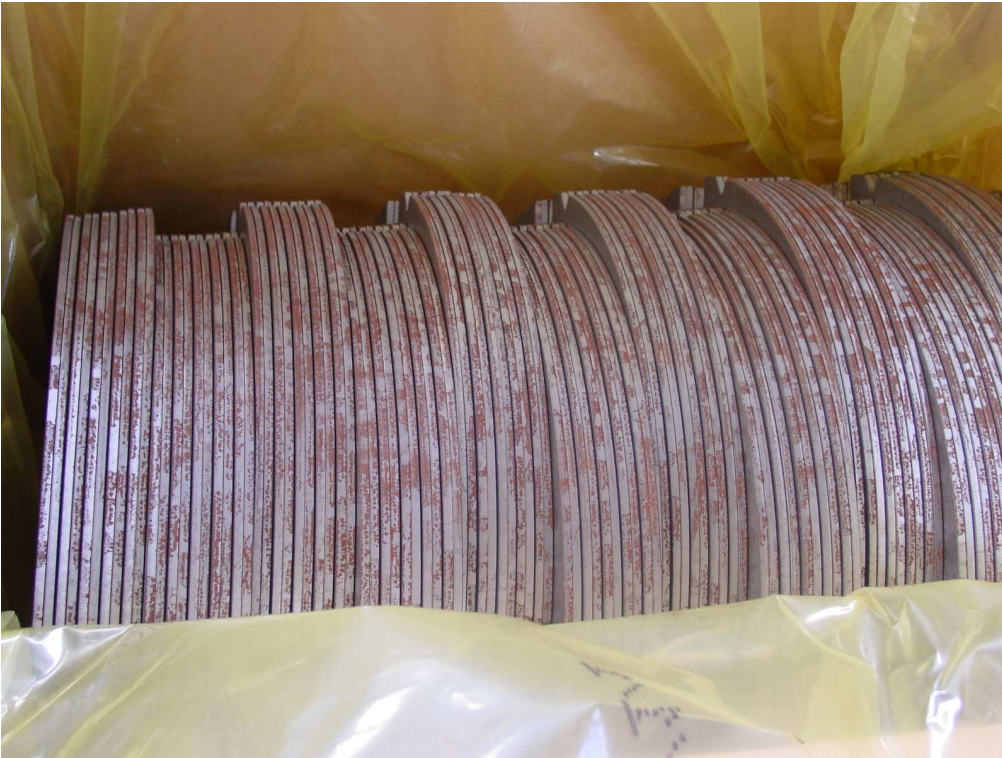
Finally there are in stock at ORMET two batches still to be stacked: FSG522 and FSG541. The following photos show the present conditions of laminations. Note that the photo about batch FSG541 has been taken two days after the delivery with oxidation already evident.

In order to properly clean such lamination 1.5 hours/pack has been estimated which means 24 hours of extra-works for each batch
